PACP Report with Pipe Run and Incident Snapshots

Surveyed by: ANDREW		Certificate number: T-507-4975		Owner: CITY OF MARION		Customer:		Drainage area:		P/O number:		Sheet number:							
Pipe segment ref.: MH3_MH2				Start date/time: 20240627 13:01		Street: 1432 HOLLAND ROAD				City: MARION, OH									
Location details:				Upstream MH No: MH3				Rim to invert:		Grade to invert:		Rim to grade:							
Pipe use: CB		Direction: D		Flow control:		Downstream MH No: MH2				Rim to invert:		Grade to invert:		Rim to grade:					
Height: 72 in.		Width:		Shape: C		Material: BR		Lining method:		Pipe joint length:		Total length: 313.300 ft.		Length surveyed: 313.300 ft.		Purpose: B		Sewer category:	
Media label:				Pre-cleaning: N		Date cleaned:		Weather: 1		Location code: C		Pressure value:							
Project name: ROCK SWALE 72 IN INSPECTION				Additional info:

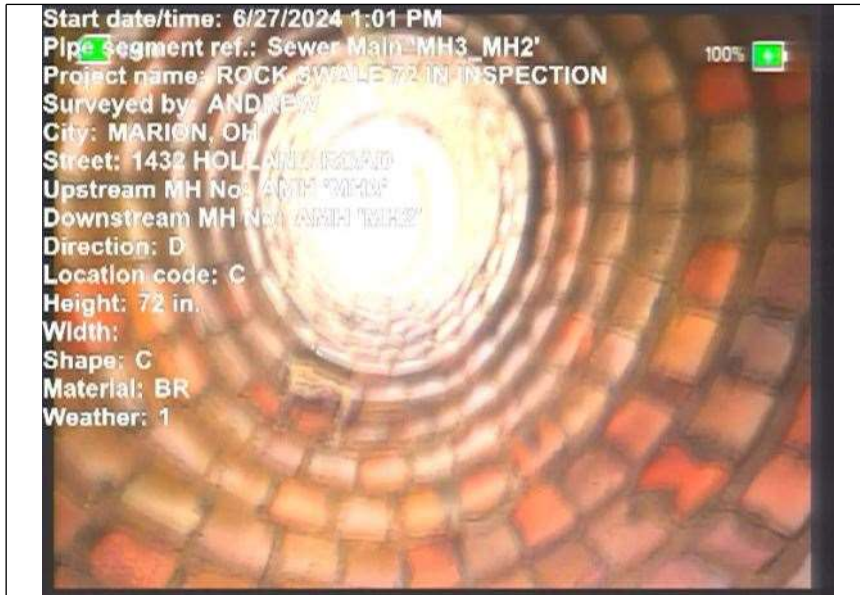
Distance: 0.1 ft.
MMS - Missing Mortar Small
Clock from: 5 o'clock
Clock to: 7 o'clock
Rating: 2
Dimension 1:
Dimension 2:
%:
