PACP Report with Pipe Run and Incident Snapshots

Surveyed by: ANDREW		Certificate number: T-507-4975		Owner: CITY OF MARION		Customer:		Drainage area:		P/O number:		Sheet number:							
Pipe segment ref.: MH4A_MH4				Start date/time: 20240627 09:18		Street: 1432 HOLLAND ROAD				City: MARION, M OH									
Location details:				Upstream MH No: MH4A				Rim to invert:		Grade to invert:		Rim to grade:							
Pipe use: CB		Direction: U		Flow control:		Downstream MH No: MH4				Rim to invert:		Grade to invert:		Rim to grade:					
Height: 72 in.		Width:		Shape: C		Material: BR		Lining method:		Pipe joint length:		Total length: 1,190.200 ft.		Length surveyed: 1,190.200 ft.		Purpose: B		Sewer category:	
Media label:				Pre-cleaning: N		Date cleaned:		Weather: 1		Location code: C		Pressure value:							
Project name: ROCK SWALE 72 IN INSPECTION				Additional info:

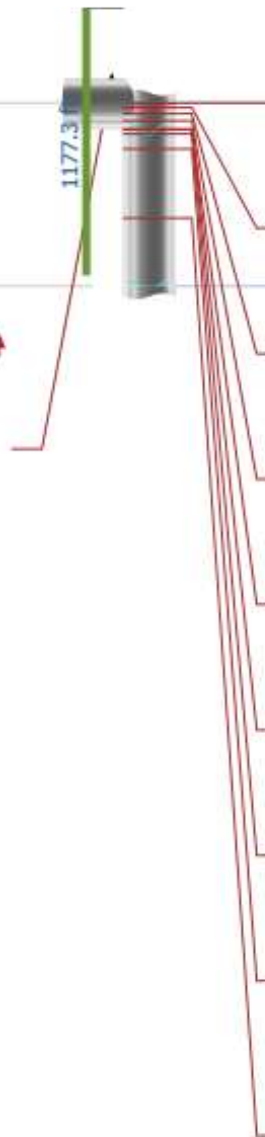
At 173.1 ft. 7/.
TBD - Tap Break-in/Hammer
Defective
Dimension 1: 10.000
Rating: ■
Category: O&M
Comments: ENTERS PIPE AT OR
BELOW FLOW LINE

- ↑ At 174.1 ft. 7/.
MB - Missing Brick
Rating: ■
Category: Structural
- ↑ At 169.6 ft. 9/.
RFB - Roots Fine Barrel
Rating: 2
Category: O&M
- ↑ At 163.8 ft. 3/.
RTB - Roots Tap Barrel
Rating: ■
Category: O&M
- ↑ At 157.3 ft. 3/.
RTB - Roots Tap Barrel
Rating: ■
Category: O&M
- ↑ At 149.4 ft. 3/.
RFB - Roots Fine Barrel
Rating: 2
Category: O&M
- ↑ At 149.1 ft. 7/9
RFB - Roots Fine Barrel
Rating: 2
Category: O&M
- ↑ At 145.0 ft. 3/5
RTB - Roots Tap Barrel
Rating: ■
Category: O&M
- ↑ At 131.1 ft. 2/.
RFB - Roots Fine Barrel
Rating: 2
Category: O&M
- ↑ At 66.5 ft. 9/.
OBI - Obstruction Intruding
Through Wall
Rating: ■
Category: O&M
Comments: STAKE OR NAIL

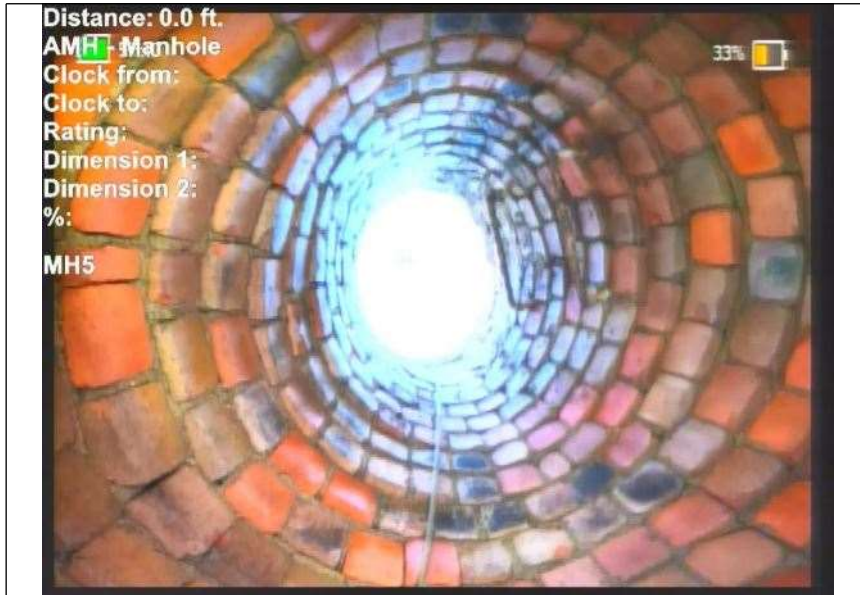
At: 0 ft. AMH - Manhole
Joint: No MH4

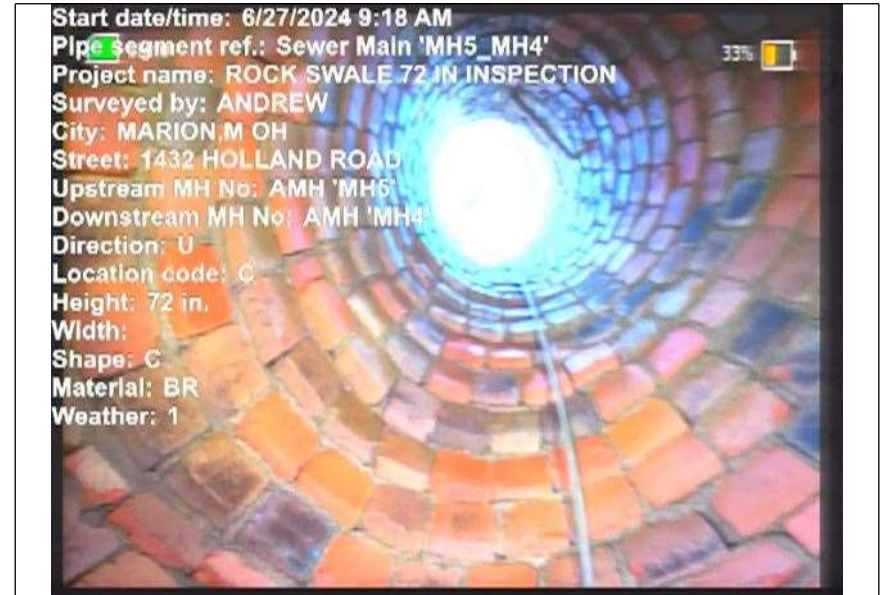
At: 0 ft. AMH - Manhole
Joint: No MH4
