PACP Report with Pipe Run and Incident Snapshots

Surveyed by: ANDREW		Certificate number: T-507-4975		Owner: CITY OF MARION		Customer:		Drainage area:		P/O number:		Sheet number:							
Pipe segment ref.: MH10_MH9				Start date/time: 20240626 08:39		Street: 876 SILVER ST.				City: MARION, OH									
Location details:				Upstream MH No: MH10				Rim to invert:		Grade to invert:		Rim to grade:							
Pipe use: CB		Direction: U		Flow control:		Downstream MH No: MH9				Rim to invert:		Grade to invert:		Rim to grade:					
Height: 66 in.		Width:		Shape: C		Material: BR		Lining method:		Pipe joint length:		Total length: 785.200 ft.		Length surveyed: 785.200 ft.		Purpose: B		Sewer category:	
Media label:				Pre-cleaning: N		Date cleaned:		Weather: 1		Location code: C		Pressure value:							
Project name: ROCK SWALE 72 IN INSPECTION				Additional info:

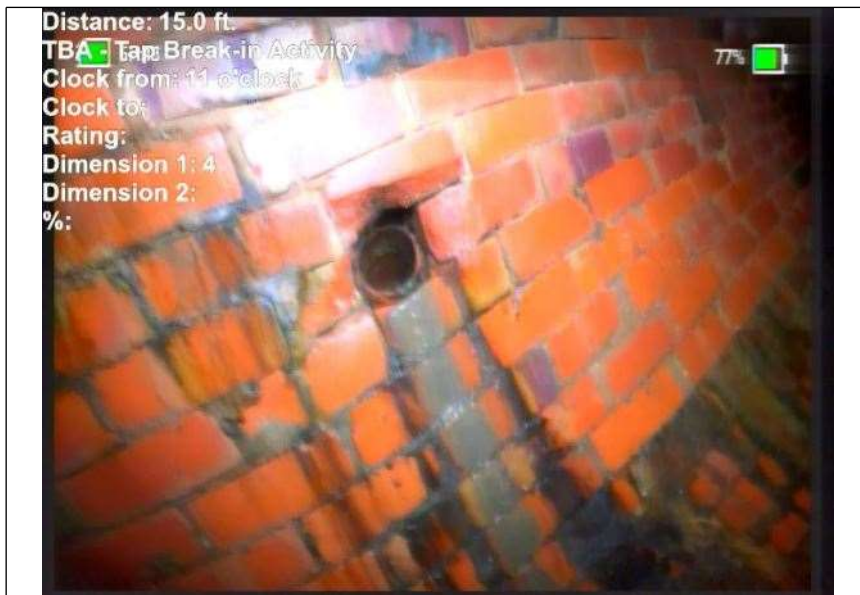
At: 15 ft. 11/. TBA - Tap Break-in Activity
Joint: No

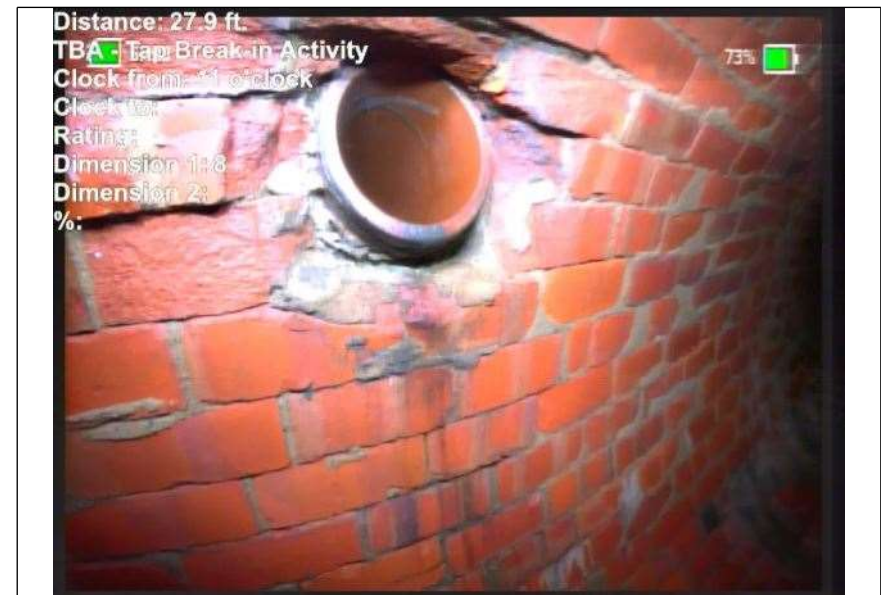
At: 27.9 ft. TBA - Tap Break-in Activity
8999996185
303 ft. 11/.
Joint: No

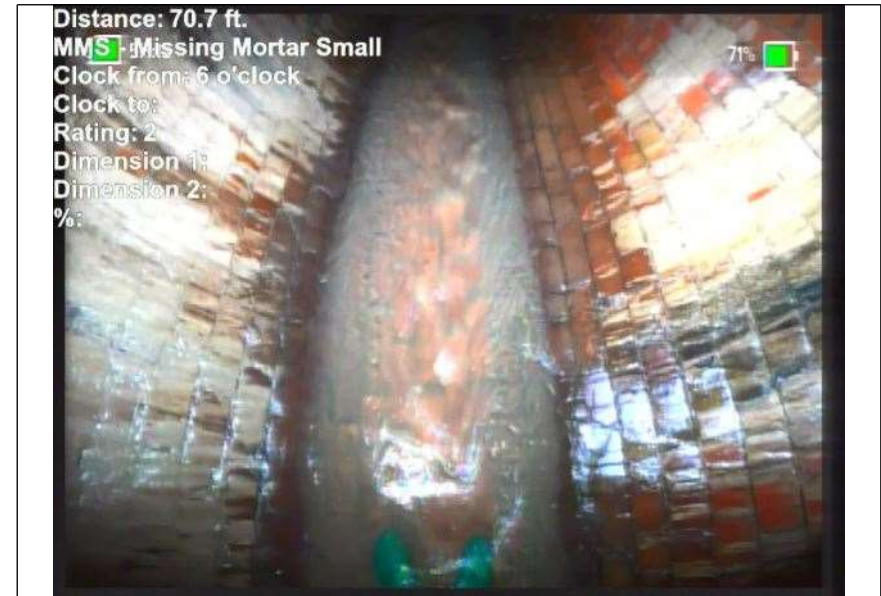
70.7 ft.	00:12:34	MMS	S01	S				<input type="checkbox"/>	6 /		2	ROCK SWALE 72 IN INSPECTION-AMH 'MH10'-AMH 'MH9'-MMS at 70.7 ft.JPG	
81.9 ft.	00:13:37	MB						<input type="checkbox"/>	11 /		4	ROCK SWALE 72 IN INSPECTION-AMH 'MH10'-AMH 'MH9'-MB at 81.9 ft.JPG	1 COURSE MISSING AROUND TAP

At 70.7 ft. 6/.
 S01: MMS - Missing Mortar Small
 Rating: 2
 Category: Structural

At: 70. 6999969482 MMS - Missing Mortar Small
422 ft. 6/.
Joint: No

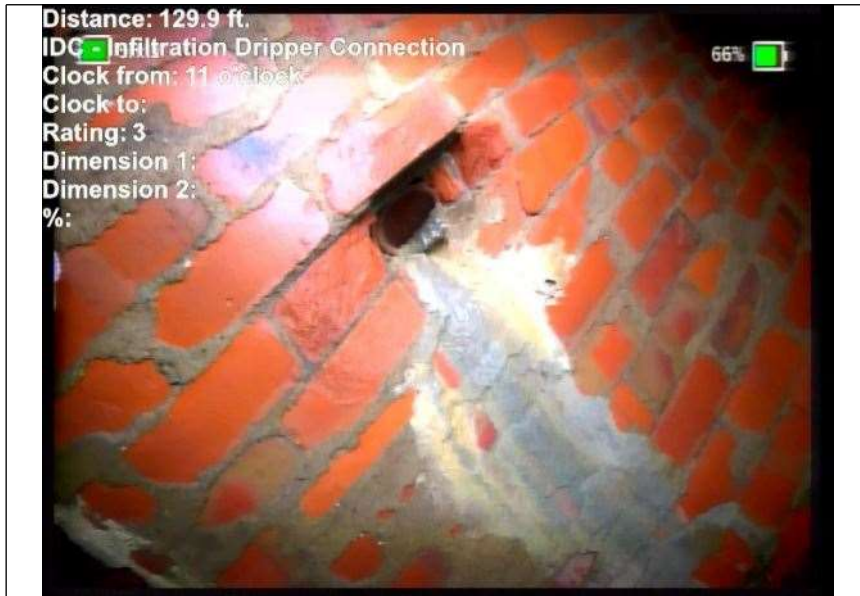
At: 129. IDC - Infiltration Dripper Connection
8999938964
84 ft. 11/.

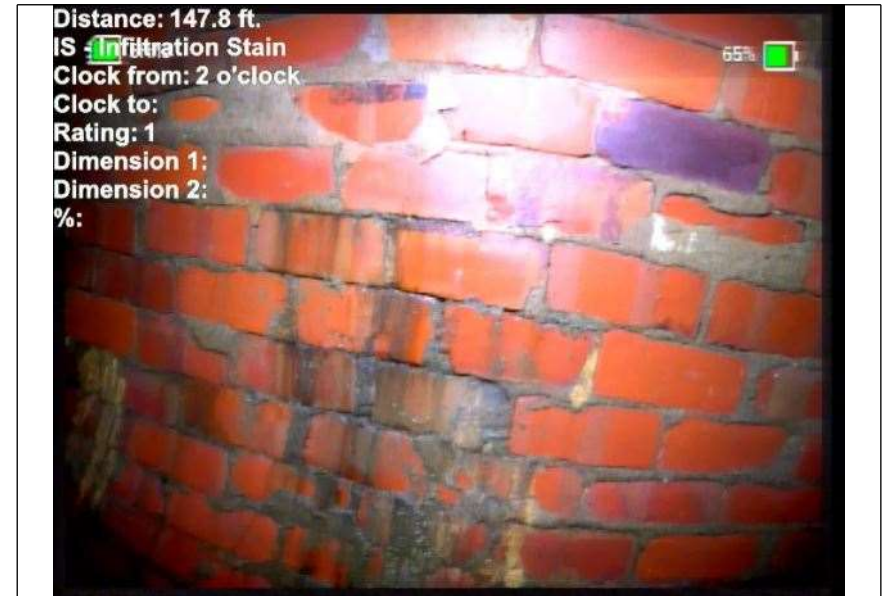
At: 147. IS - Infiltration Stain
8000030517
58 ft. 2/.

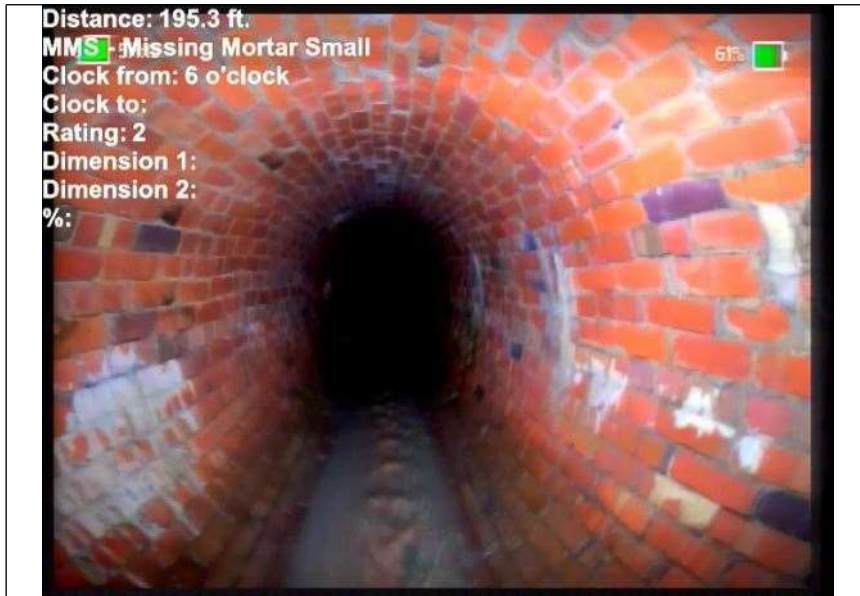
At: 195. MMS - Missing Mortar Small
3000030517
58 ft. 6/.

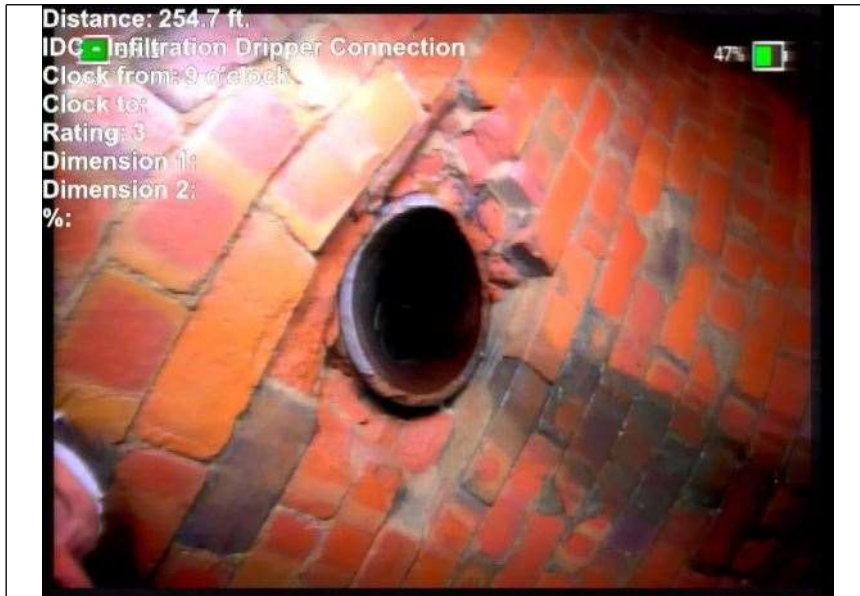
At: 254. IDC - Infiltration Dripper Connection
6999969482
42 ft. 9/.

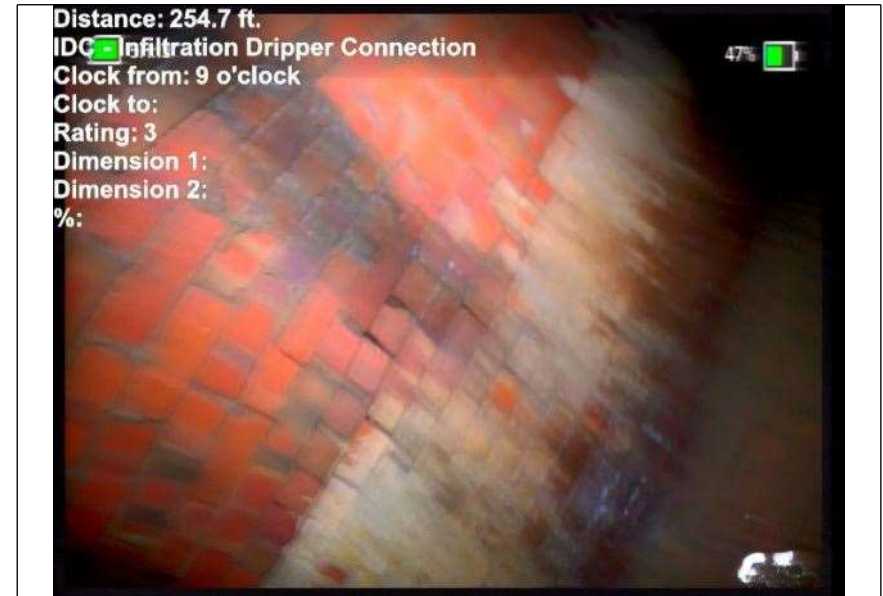
At: 254. IDC - Infiltration Dripper Connection
6999969482
42 ft. 9/.

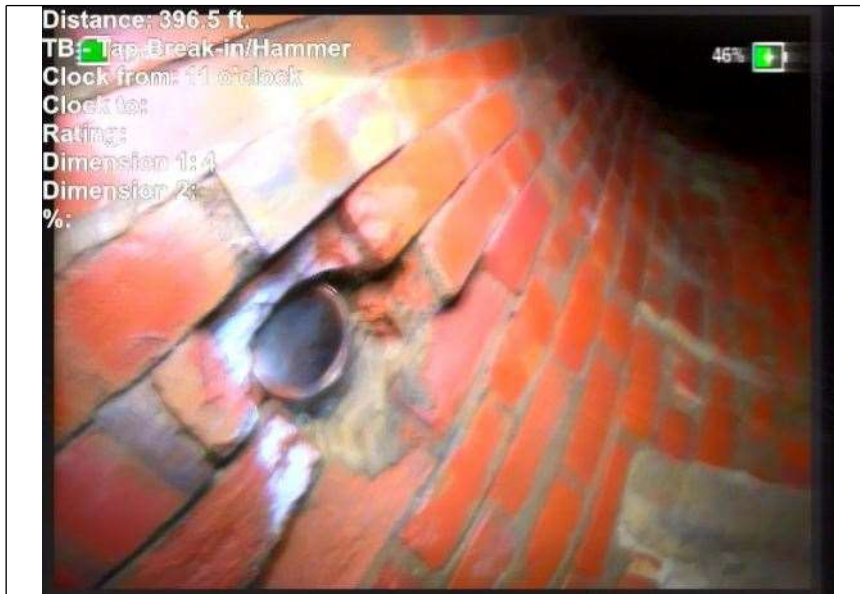
At: 396.5 ft. 11/. TB - Tap Break-in/Hammer

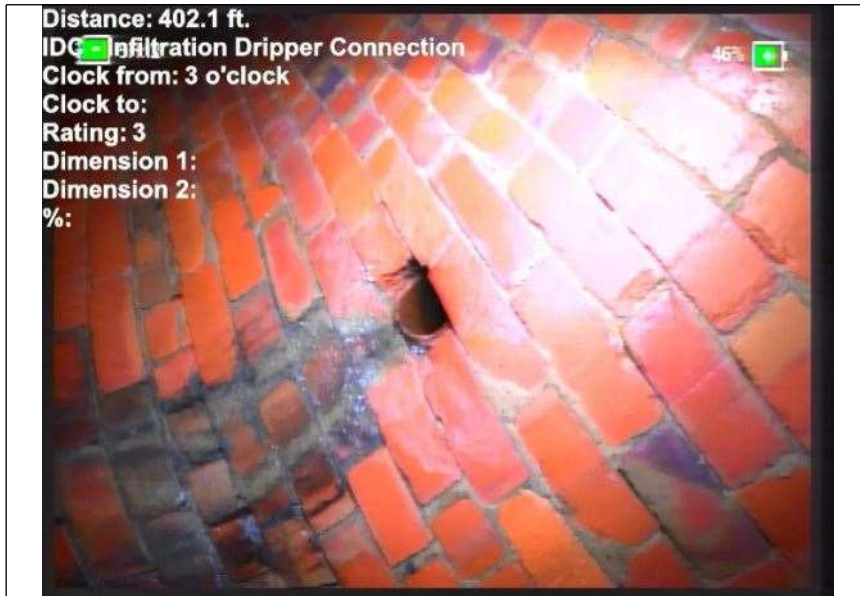
At: 402. IDC - Infiltration Drinker Connection
1000061035
16 ft. 3/.

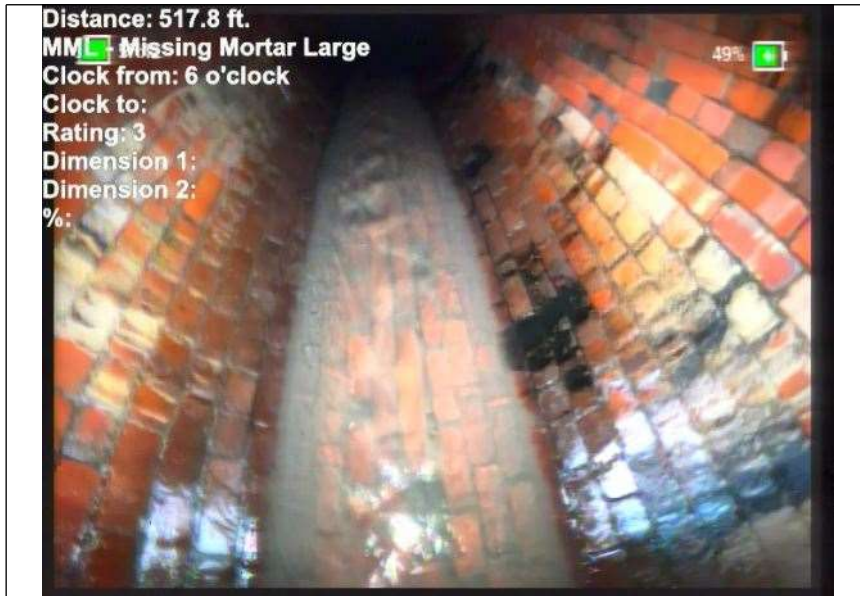
At: 517. MML - Missing Mortar Large
7999877929
69 ft. 6/.

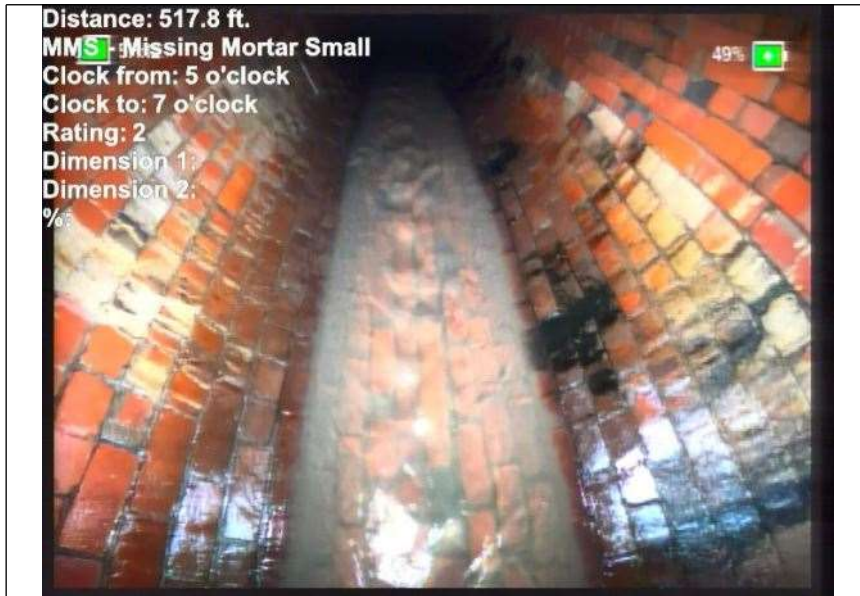
At: 517. MMS - Missing Mortar Small
7999877929
69 ft. 5/7

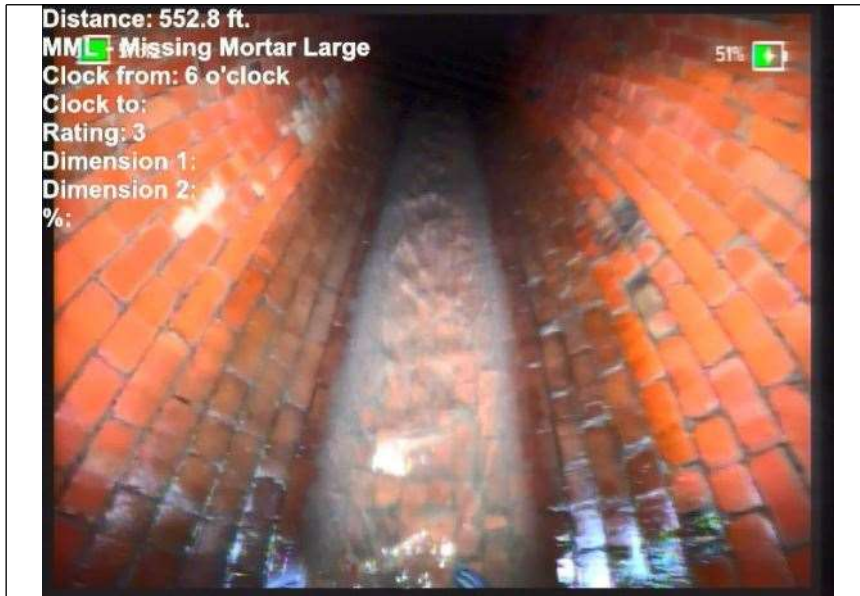
At: 552. 7999877929 MML - Missing Mortar Large
69 ft. 6/.

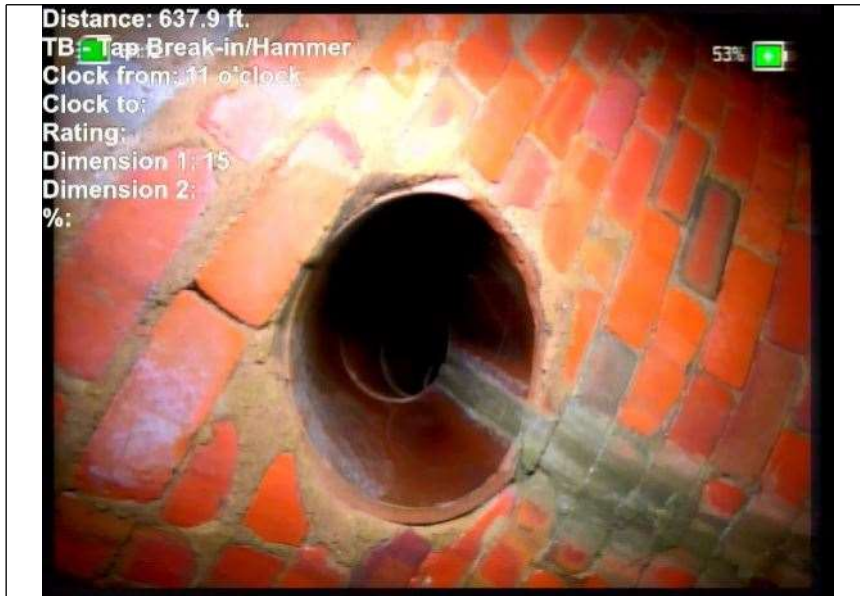
At: 637.9 ft. TB - Tap Break-in/Hammer
9000244140
63 ft. 11/.

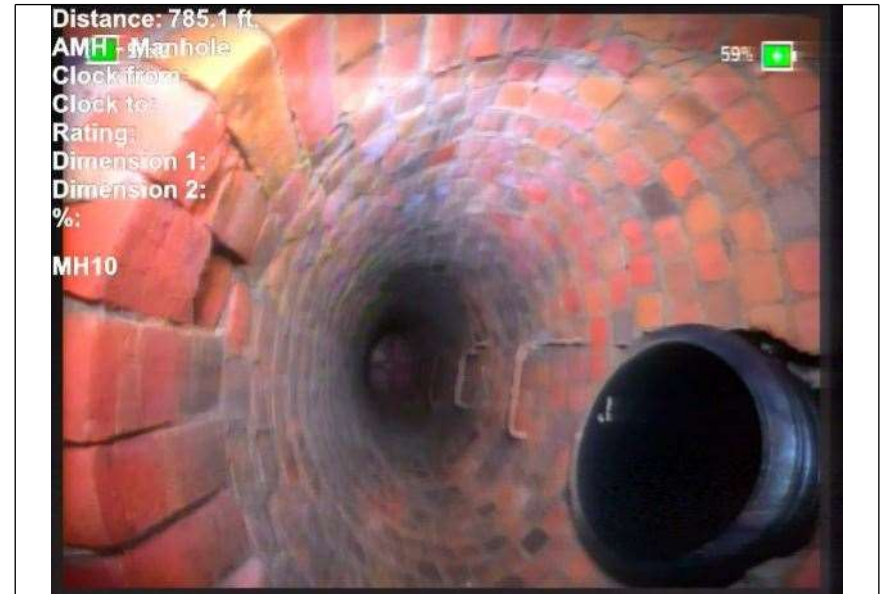
At 785.1 ft. 2/9
F04: MMS - Missing Mortar Small
Rating: 2
Category: Structural

At: 785.1 ft. 2/9 MMS - Missing Mortar Small
