Inspection	Marion County, Ohio
US Manhole	12A
DS Manhole	12
Inspected	October 10, 2024
Platform	Aerial Drone
Sensor	3D Lidar
Report Date	October 29, 2024

DATE: 10/3/2024
PIPE SEG REF. MH 12A - MH 12
UP MH: MH 12A
DOWN MH: MH 12

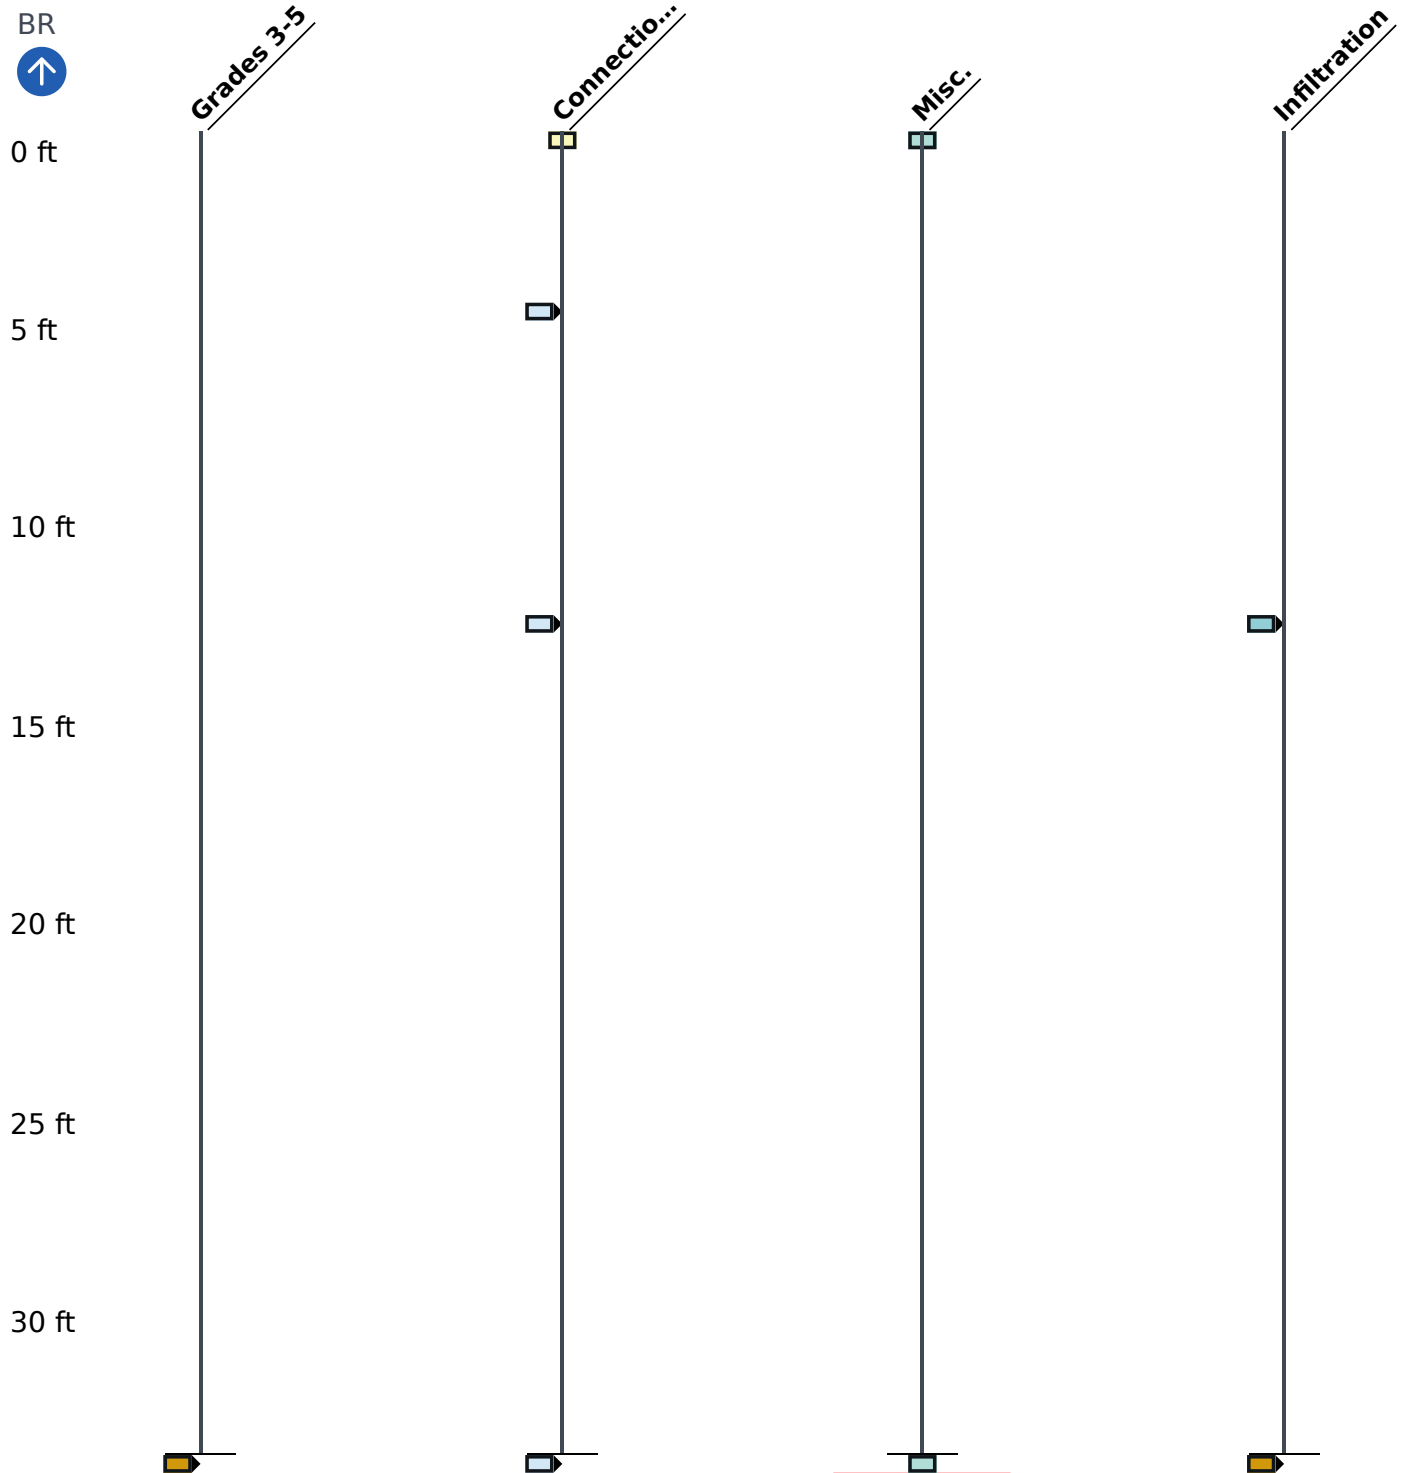
SMART DIAGRAM

Dist	Time	Description	Code	Clock	Dim. 1	Dim. 2	%	Remarks	Cont.	Grade
0	0:35	Manhole	AM	-	-	-	-	MH 12	-	-
0	0:35	Miscellaneous Water Level	MLW	-	-	-	10	-	-	-
0	0:36	Miscellaneous General Observatio...	MOG	-	-	-	-	12.4 FT DISTANCE OFFSET	-	-
2.7	0:54	Tap Break-in Activity	TBA

6	-	-	-	-	-
7.6	1:09	Tap Break-in Capped	TBC

15	-	-	-	-	-
7.6	1:11	Infiltration Weeper Lateral	IWL

-	-	-	-	-	2
20.8	1:31	Infiltration Dripper Connection	IDC

-	-	-	-	-	3
20.8	1:31	Tap Break-in/Hammer	TB
