Project:	2320059	Date/Time:	September 26 2023 - 09:56
Street and City:	PIERCE DR - BOARDMAN	Weather:	Unknown Weather
Owner:	CITY OF BOARDMAN	Inspection Status:	Complete Inspection
Customer:	ABC WATER	Segment:	BO657.08-BO657.05
Surveyor Name and Certificate:	SHAWN DUNNELL 915-70001437	Direction:	Upstream
Reviewer Name and Certificate:		Up MH:	BO657.08
P.O. #		Down MH:	BO657.05

BOARDMAN — September 26 2023	Up MH: BO657.08
Pipe: BO657.08-BO657.05	Down MH: BO657.05

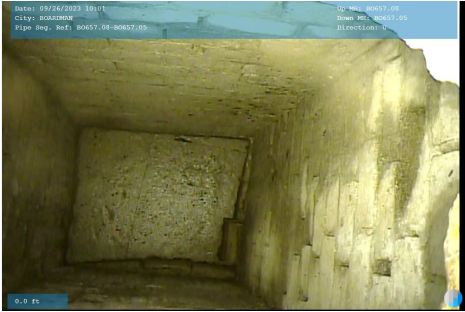
A photograph showing the interior of a manhole. The walls are made of concrete and show signs of wear and discoloration. A small, dark opening is visible in the distance. The floor is also concrete and appears slightly uneven. A small blue label in the bottom left corner reads "0.0 ft".	0	AMH - Manhole Remark = BO657.05	00:00:24

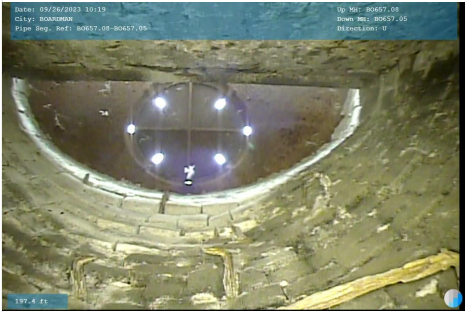
<p>DATE: 09/26/2023 10:15 CLAY: BOARDMAN Pipe Inq. Ref: BO657.08-BO657.05 Up MH: BO657.08 Down MH: BO657.05 Direction: U</p> <p>197.4 ft</p>	197.4	AMH - Manhole Remark = BO657.08	00:09:53
