Project:	2420009	Date/Time:	January 31 2024 - 12:16
Street and City:	TURNBERRY DR - YOUNGSTOWN	Weather:	Dry Weather/Wet Ground
Owner:	CITY OF YOUNGSTOWN	Inspection Status:	Complete Inspection
Customer:	CT CONSULTANTS	Segment:	MY00001_P1_M04-MY00001_P1_M05
Surveyor Name and Certificate:	SHAWN DUNNELL U-915-70001437	Direction:	Upstream
Reviewer Name and Certificate:		Up MH:	MY00001_P1_M04
P.O. #		Down MH:	MY00001_P1_M05

Pipe: MY00001_P1_M04-MY00001_P1_M05

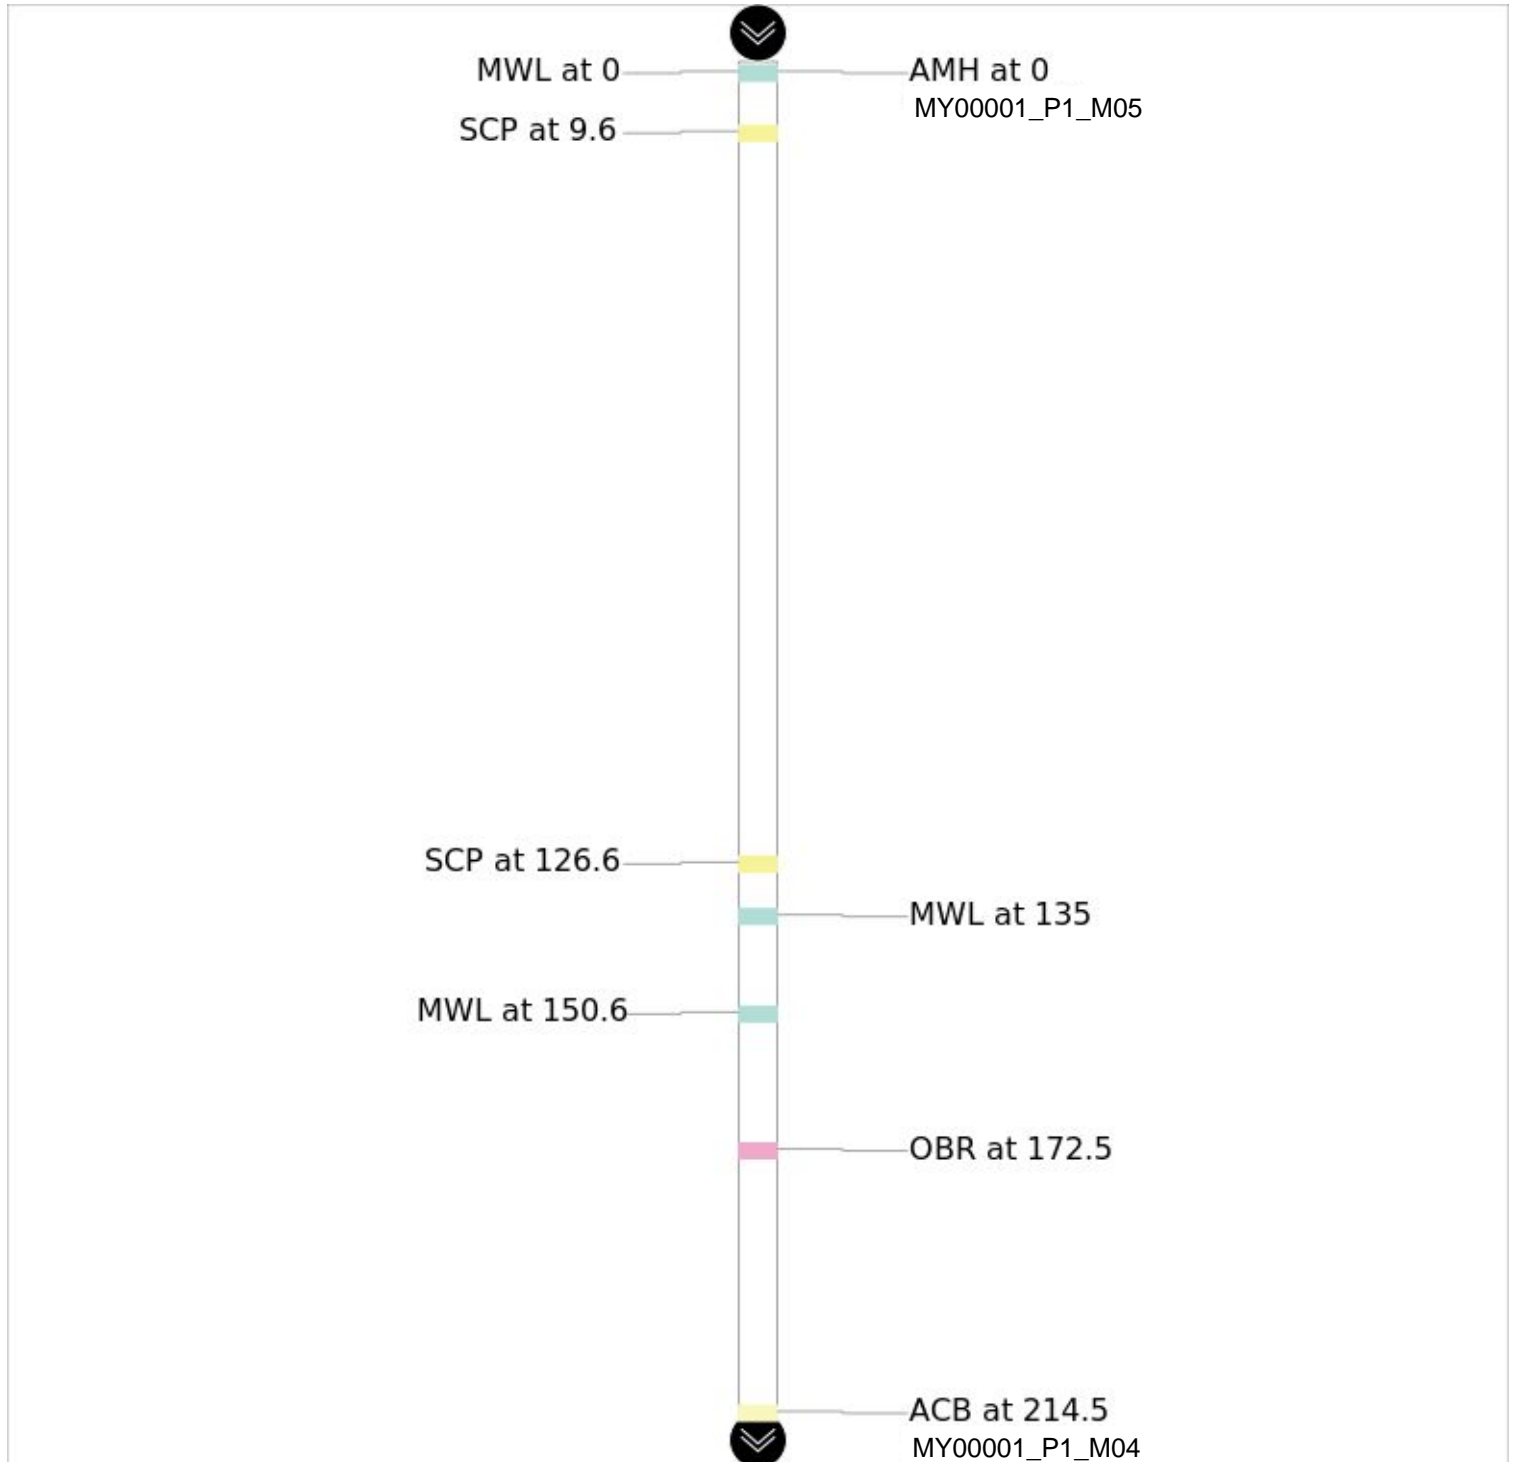
9.6	SCP - Surface Damage Corrosion Continuous: S01 Clock from 4 to 8 Grade = 3	00:01:14

126.6	SCP - Surface Damage Corrosion Continuous: F01 Clock from 4 to 8 Grade = 3	00:05:51
