TELEVISING REPORT

CUSTOMER: County of Lake
Stormwater Management Department
125 E. Erie Street
Painesville, Ohio 44077
Attn.: Mr. Tim Miller

JOB LOCATION: City of Fairport Harbor

~Orange Line Storm Sewer Inspection~ (See Attached Location Map)

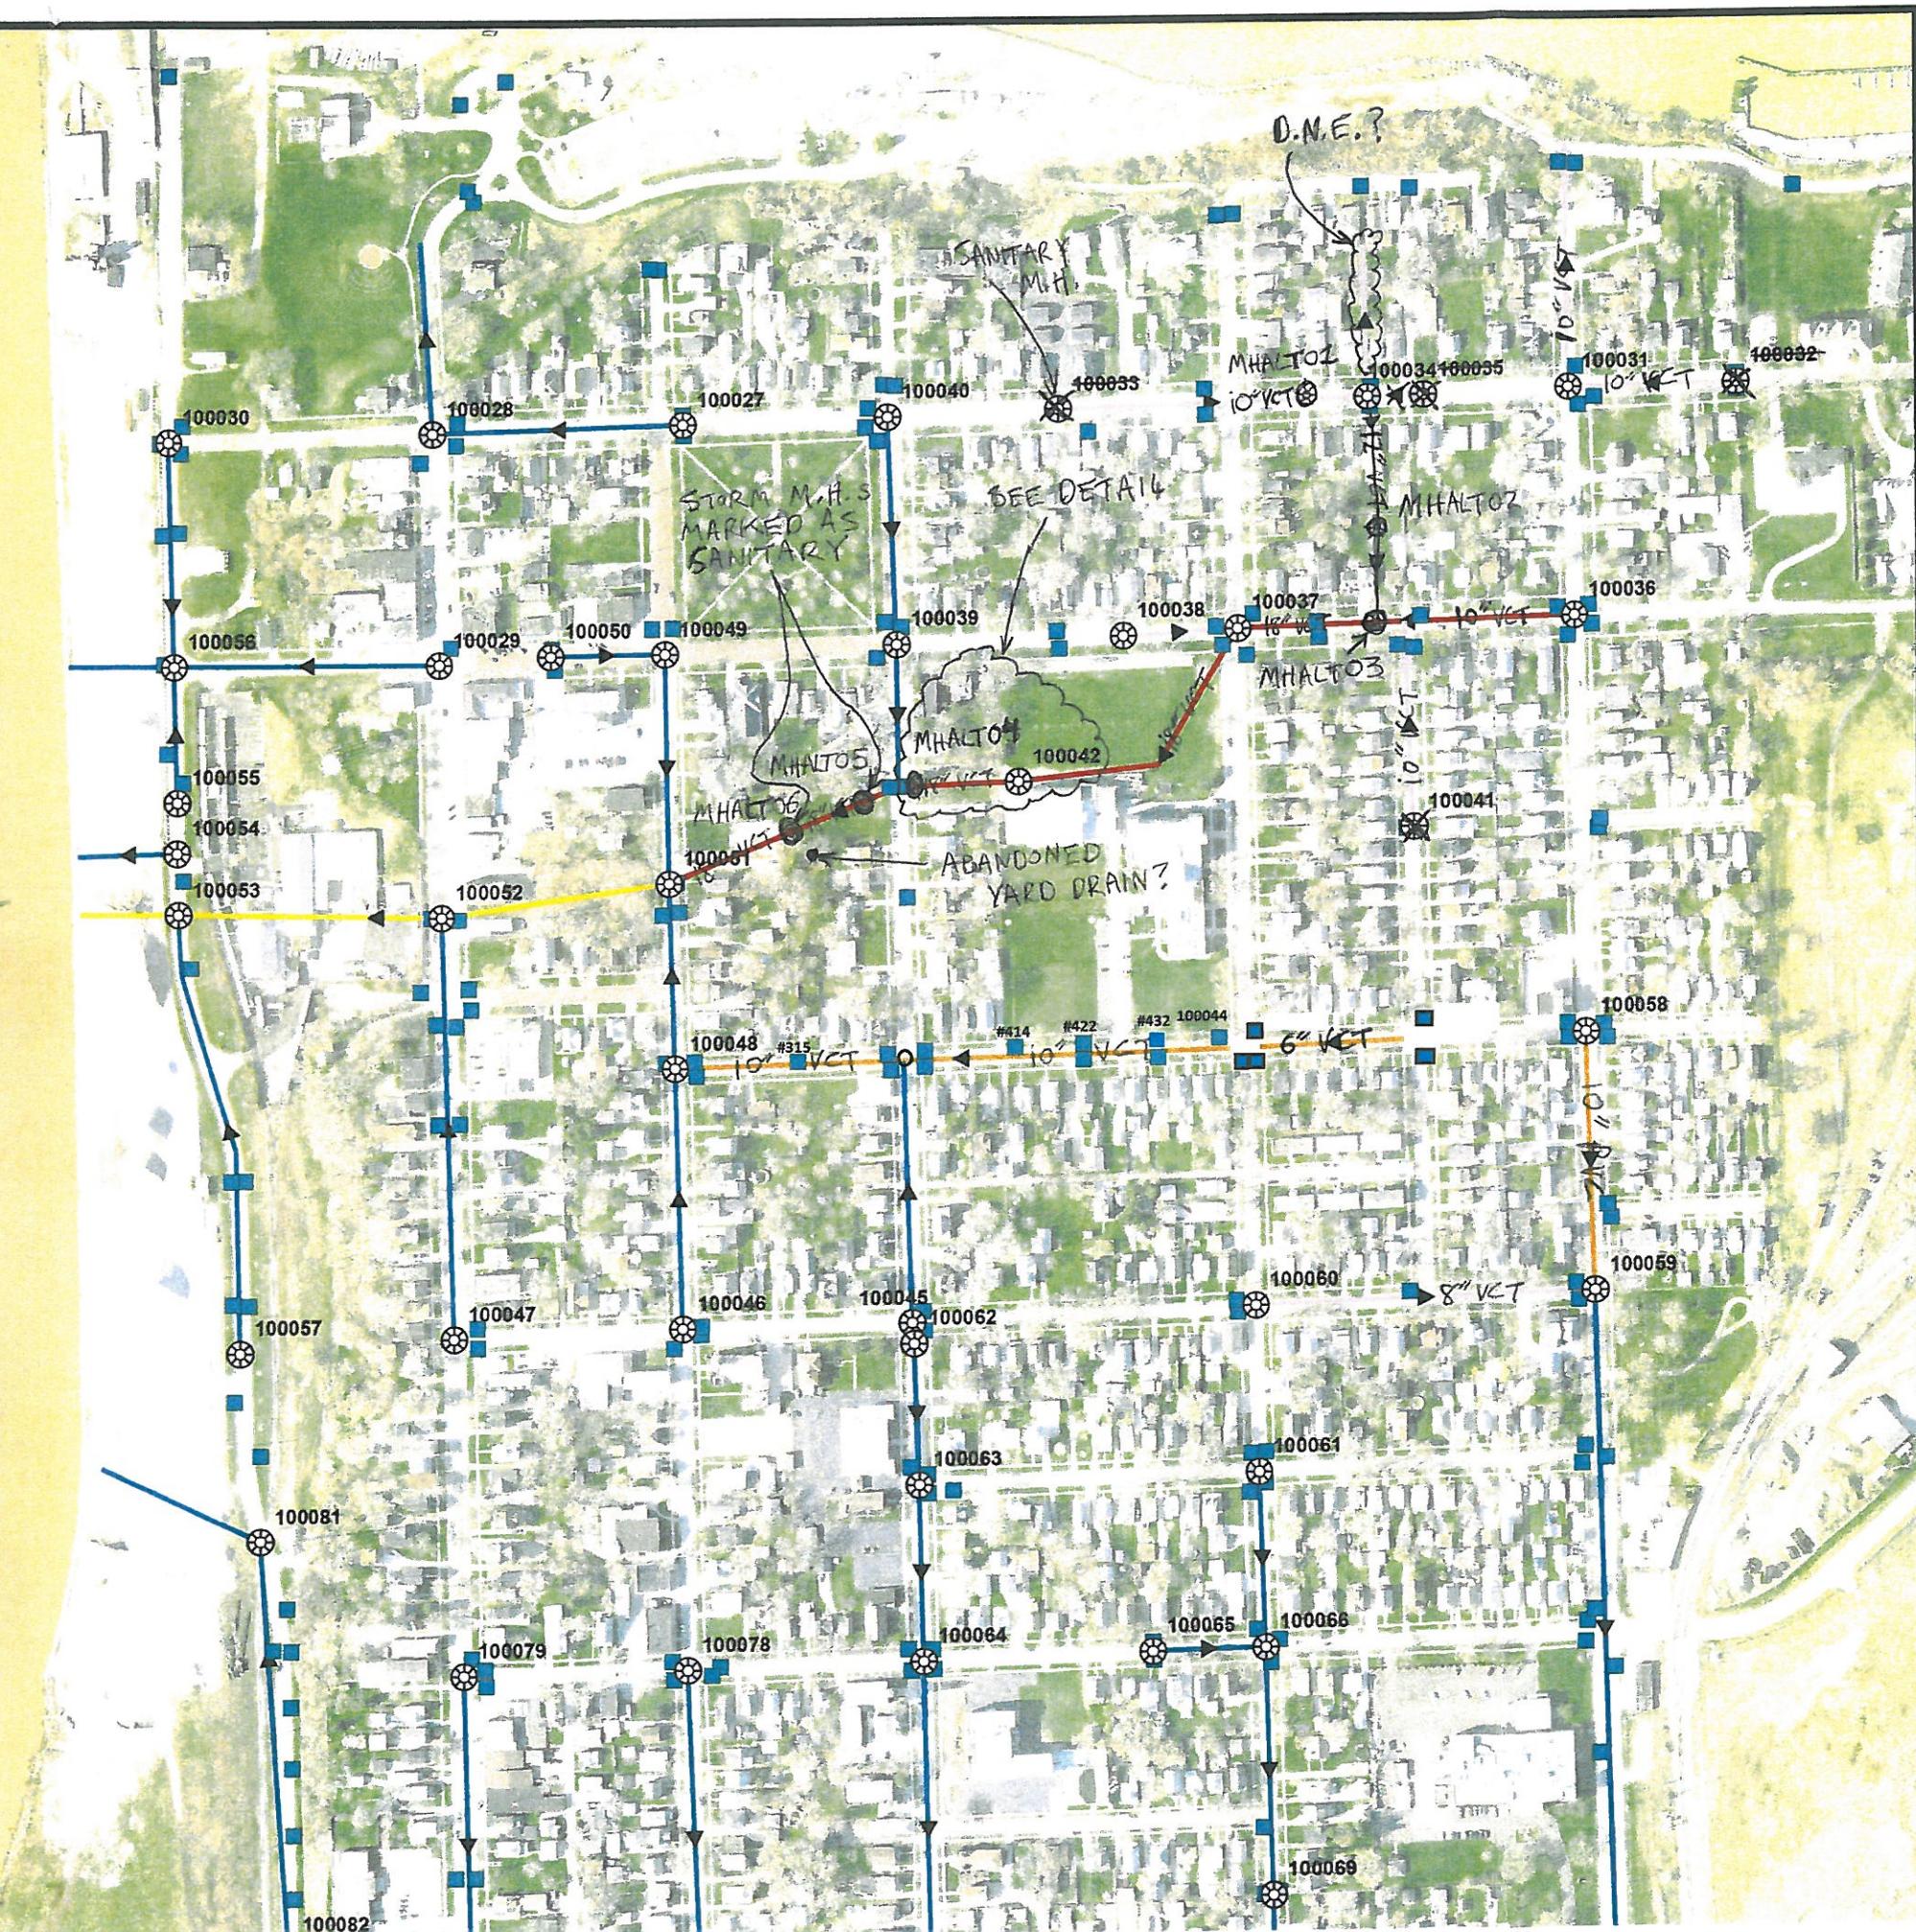
FAIRPORT HARBOR STORM SEWER
RECONNAISSANCE

- OBSERVED MANHOLE LOCATIONS:

<u>M.H.#</u>	<u>M.H. LOCATION</u>
100031	N.E. CORNER OF EAST ST. & 2 ND ST.
100034	S. SIDE OF 2 ND ST. BETWEEN VINE & EAST ST.
MHALTO1	IN DRIVEWAY ON N. SIDE OF 2 ND ST. (S07 2 ND ST.)
MHALTO2	IN BACK YARD OF 513 3 RD ST. (NOT LOCATED)
MHALTO3	IN DRIVEWAY AT 516 3 RD ST.
100036	S.E. CORNER OF EAST ST. & 3 RD ST.
100037	S.W. CORNER OF VINE ST. & 3 RD ST.
100042	IN FIELD NEAR WEST ACCESS DRIVE. (SEE DETA
MHALTO4	N OF FENCE AT NE CORNER OF PLUM ST + ACCE
MHALTO5	EMPTY LOT N OF 329 PLUM ST. (W SIDE)
MHALTO6	EMPTY LOT N OF 332 EAGLE ST. (E OF PARKING)
100051	EMPTY LOT S OF 323 EAGLE ST. (W SIDE)
100044	IN TREE LAWN NEAR NW CORNER OF VINE + NEW
100048	NE CORNER OF NEW 4 TH & EAGLE ST.
100058	MIDDLE OF S.B. LANE AT NEW 4 TH + EAST
100059	MIDDLE OF S.B. LANE AT 5 TH + EAST ST.
100041	M.H. IN EITHER W OR E C.B. NEAR 324 1
100060	M.H. IN NE C.B. AT VINE + 5 TH ST.
