Village of Marblehead Marblehead, Ohio

Geotechnical Subsurface Investigation Proposed Waterline Installation Johnson's Island, Marblehead, Ohio

January 2015

**Geotechnical Subsurface Investigation
Proposed Waterline Installation
Johnson's Island, Marblehead, Ohio**

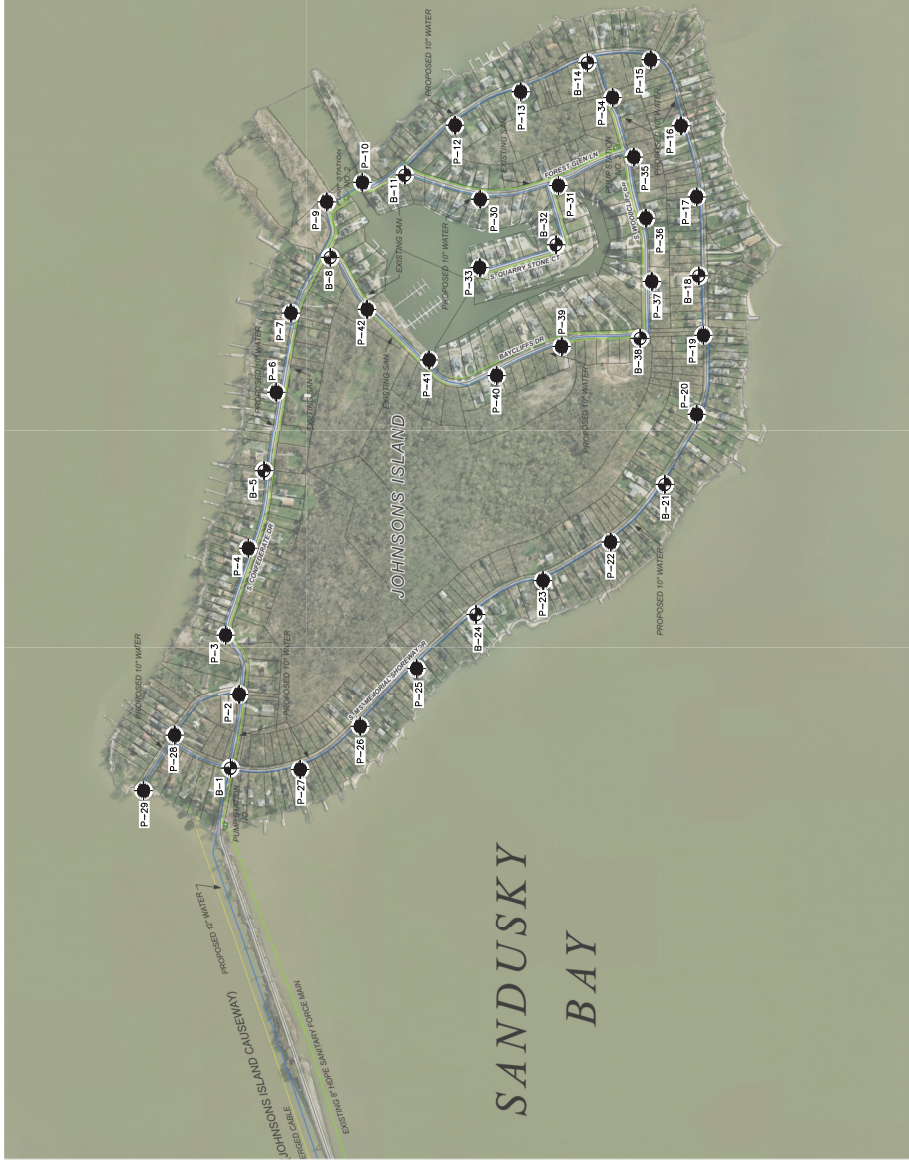
The majority of the probes/borings were drilled through the paved roadway surface, as access to areas off of the roadway was limited due to the presence of snow and snow piles at the time of this investigation. The approximate as-drilled locations of the probes are shown on the Test Probe Location Plan (Plate 2.0).

Attachments: Plate 1.0 Site Location Map
Plate 2.0 Test Boring Location Plan
Logs of Borings
Legend Key
Tabulation of Test Data
Grain Size Distribution

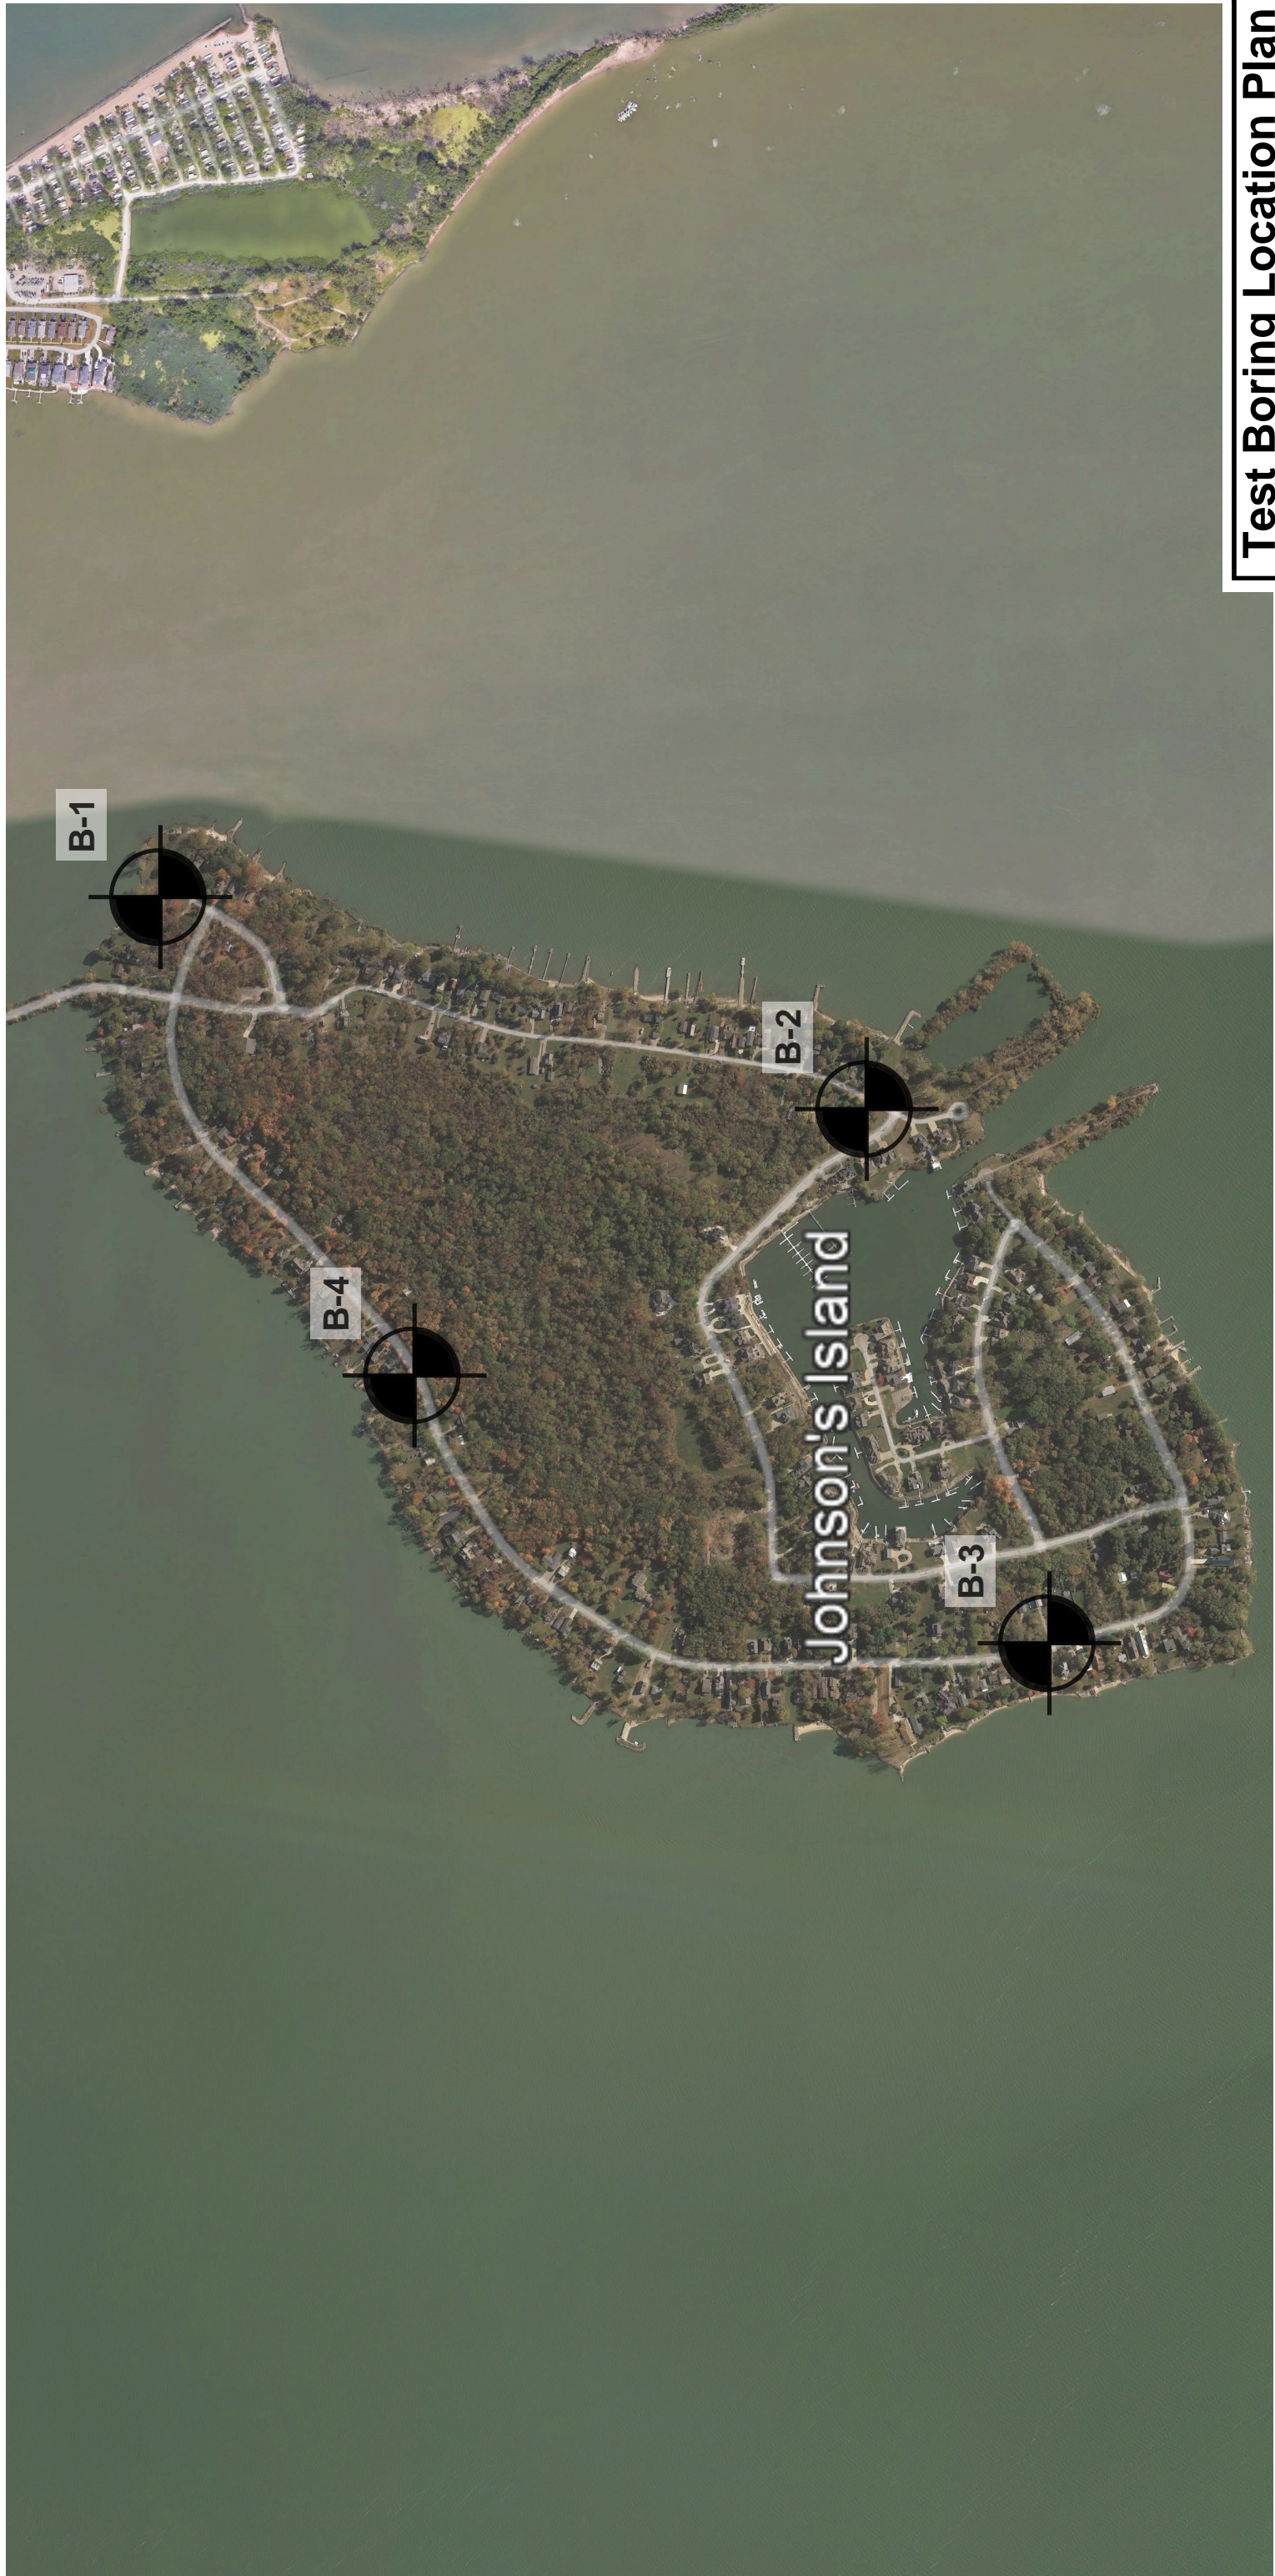
DRAWN:	RK 09/13/23
REVISED:	---
Project No.:	210900
Drawing No.:	Plate 2.0

Legend:

Plate 2.0 Test Boring Location Plan

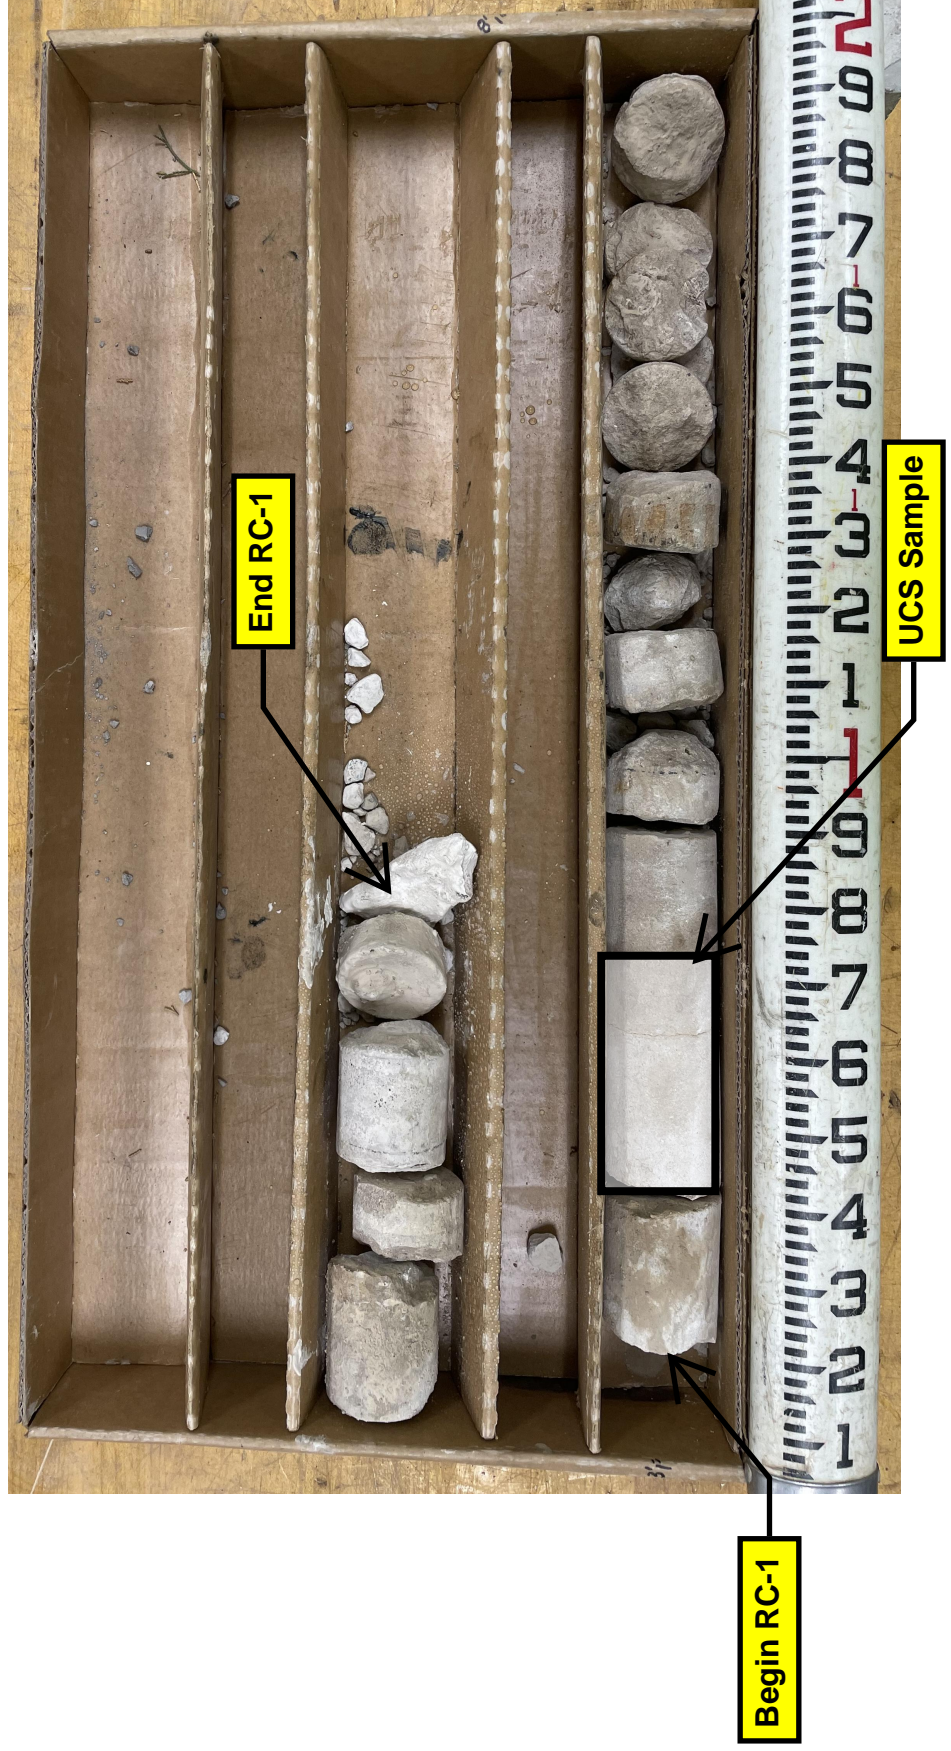
Depth (feet)
3.1 to 8.1

Elevation (feet)
573.9 to 568.9
