Inspection	Marion County, Ohio
US Manhole	11
DS Manhole	9
Inspected	October 10, 2024
Platform	Aerial Drone
Sensor	3D Lidar
Report Date	October 29, 2024

DATE: 10/10/2024
PIPE SEG REF. MH 11 - MH 9
UP MH: MH 11
DOWN MH: MH 9

Inspection Date 10/10/2024 12:00 AM	Pipe Segment Reference MH 11 - MH 9	Surveyed By SHAWN DUNNELL	Certificate Number U-915-70001437
Project 2420053PW	Street SILVER ST	Upstream MH MH 11	Downstream MH MH 9
Direction Upstream	Pre-Cleaning No Pre-Cleaning	Total Length (ft)	Length Surveyed (ft) 717.4

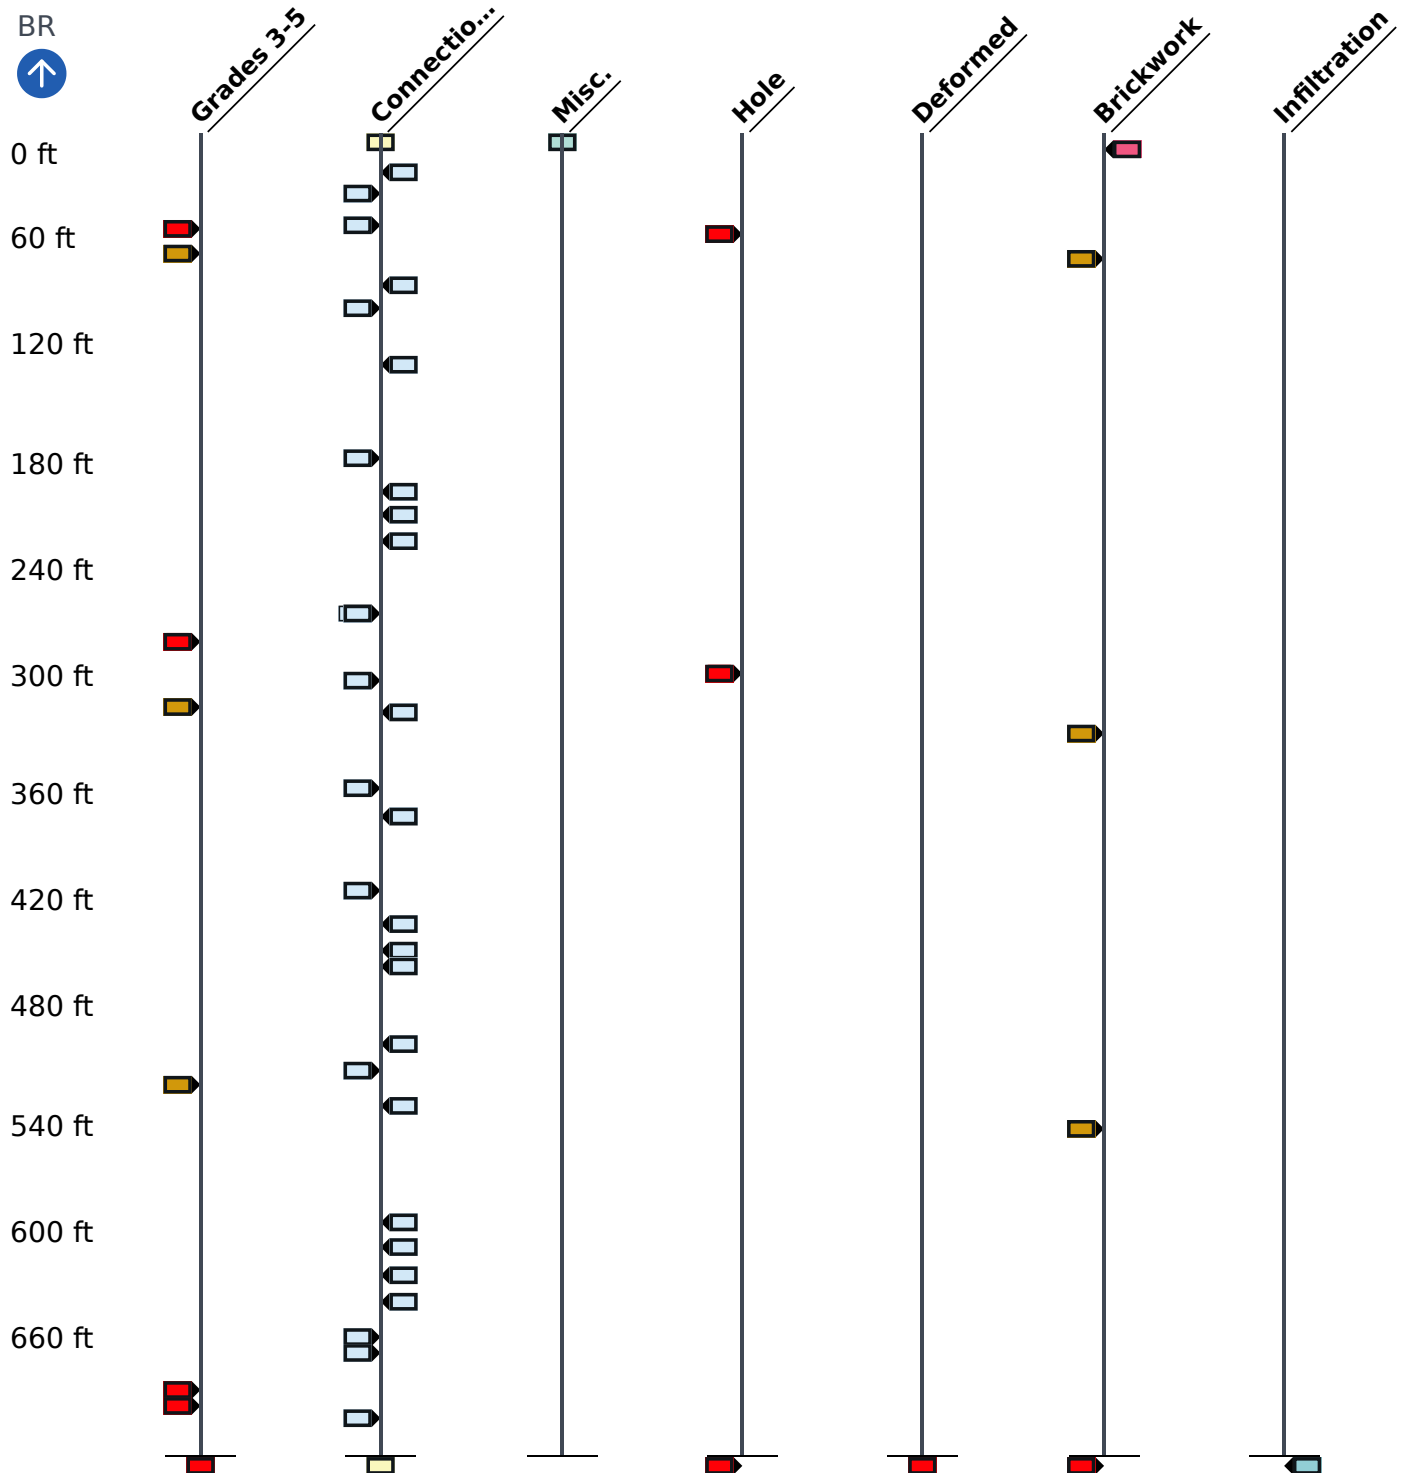
SMART DIAGRAM

DATE: 10/10/2024
 PIPE SEG REF. MH 11 - MH 9
 UP MH: MH 11
 DOWN MH: MH 9

Dist	Time	Description	Code	Clock	Dim. 1	Dim. 2	%	Remarks	Cont.	Grade
0	0:00	Manhole	AMH	-	-	-	-	MH 9	-	-
0	0:15	Miscellaneous Water Level	MW	-	-	-	5	-	-	-
3.9	0:18	Missing Mortar Small	MMS
