<b>Inspection</b>	Marion County, Ohio
<b>US Manhole</b>	4A
<b>DS Manhole</b>	4
<b>Inspected</b>	October 3, 2024
<b>Platform</b>	Aerial Drone
<b>Sensor</b>	3D Lidar
<b>Report Date</b>	October 29, 2024

**DATE:** 10/3/2024  
**PIPE SEG REF.** MH 4A - MH 4  
**UP MH:** MH 4A  
**DOWN MH:** MH 4

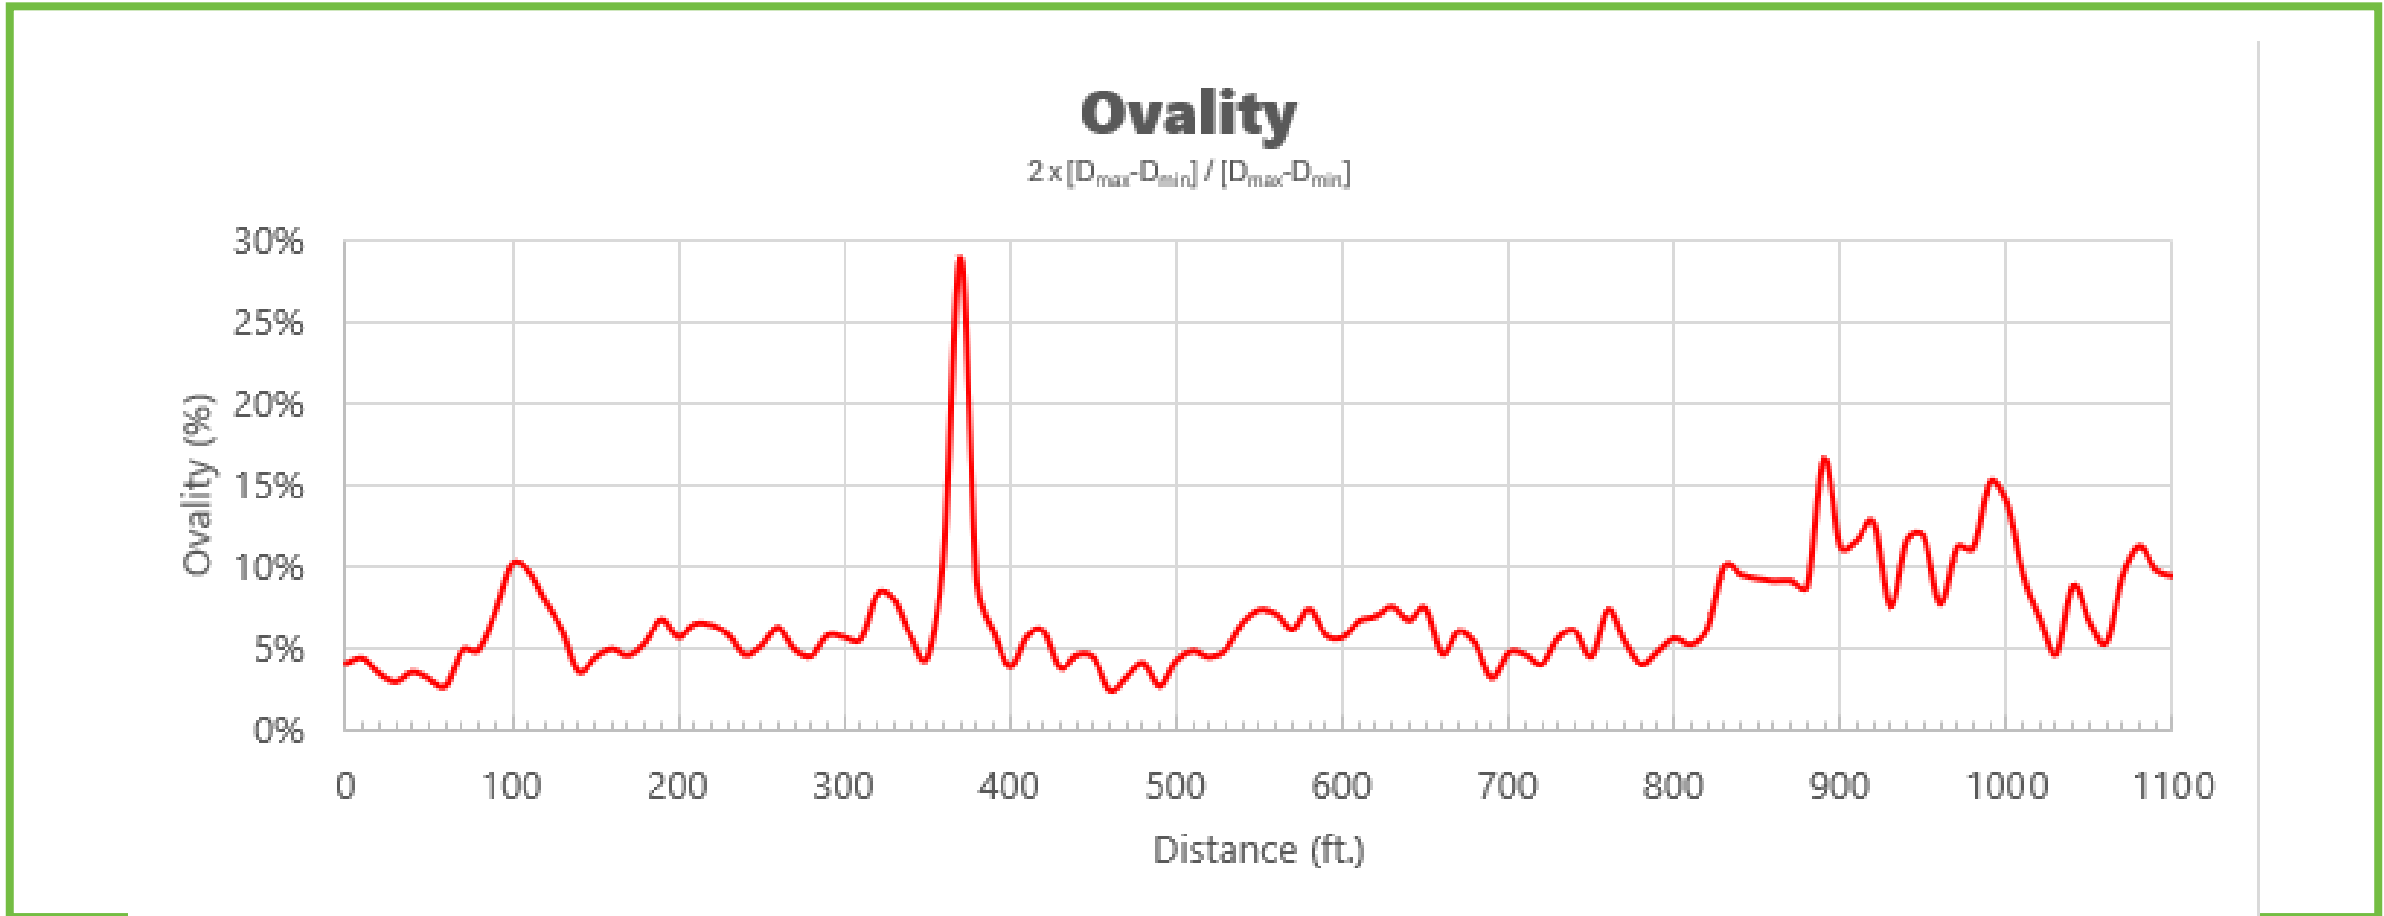
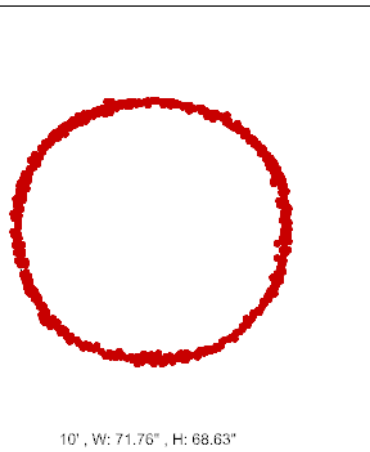
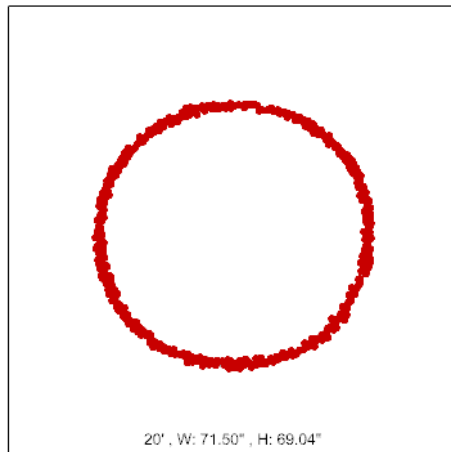
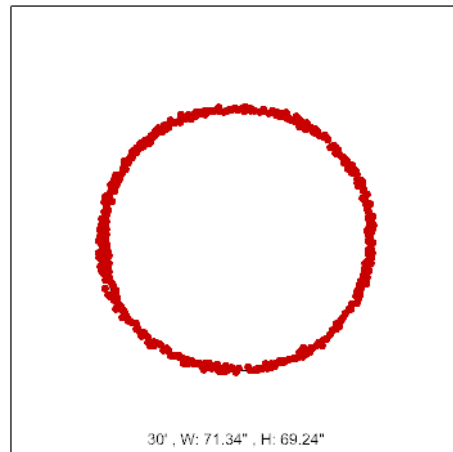
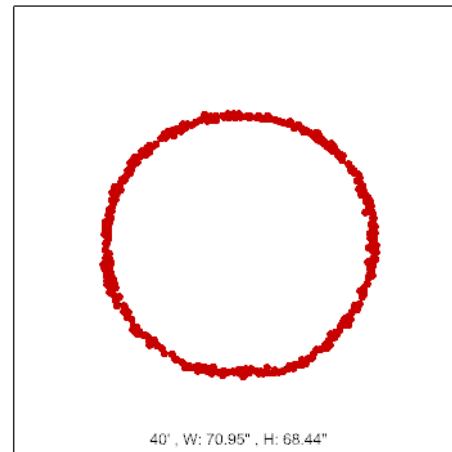
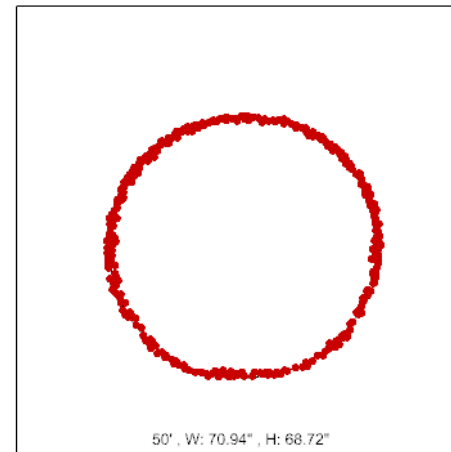
60° , W: 70.92" , H: 69.00"

70° , W: 71.36" , H: 67.93"

80° , W: 71.26" , H: 67.79"

90° , W: 72.24" , H: 67.14"

100° , W: 73.15" , H: 66.03"

110° , W: 73.28" , H: 66.44"

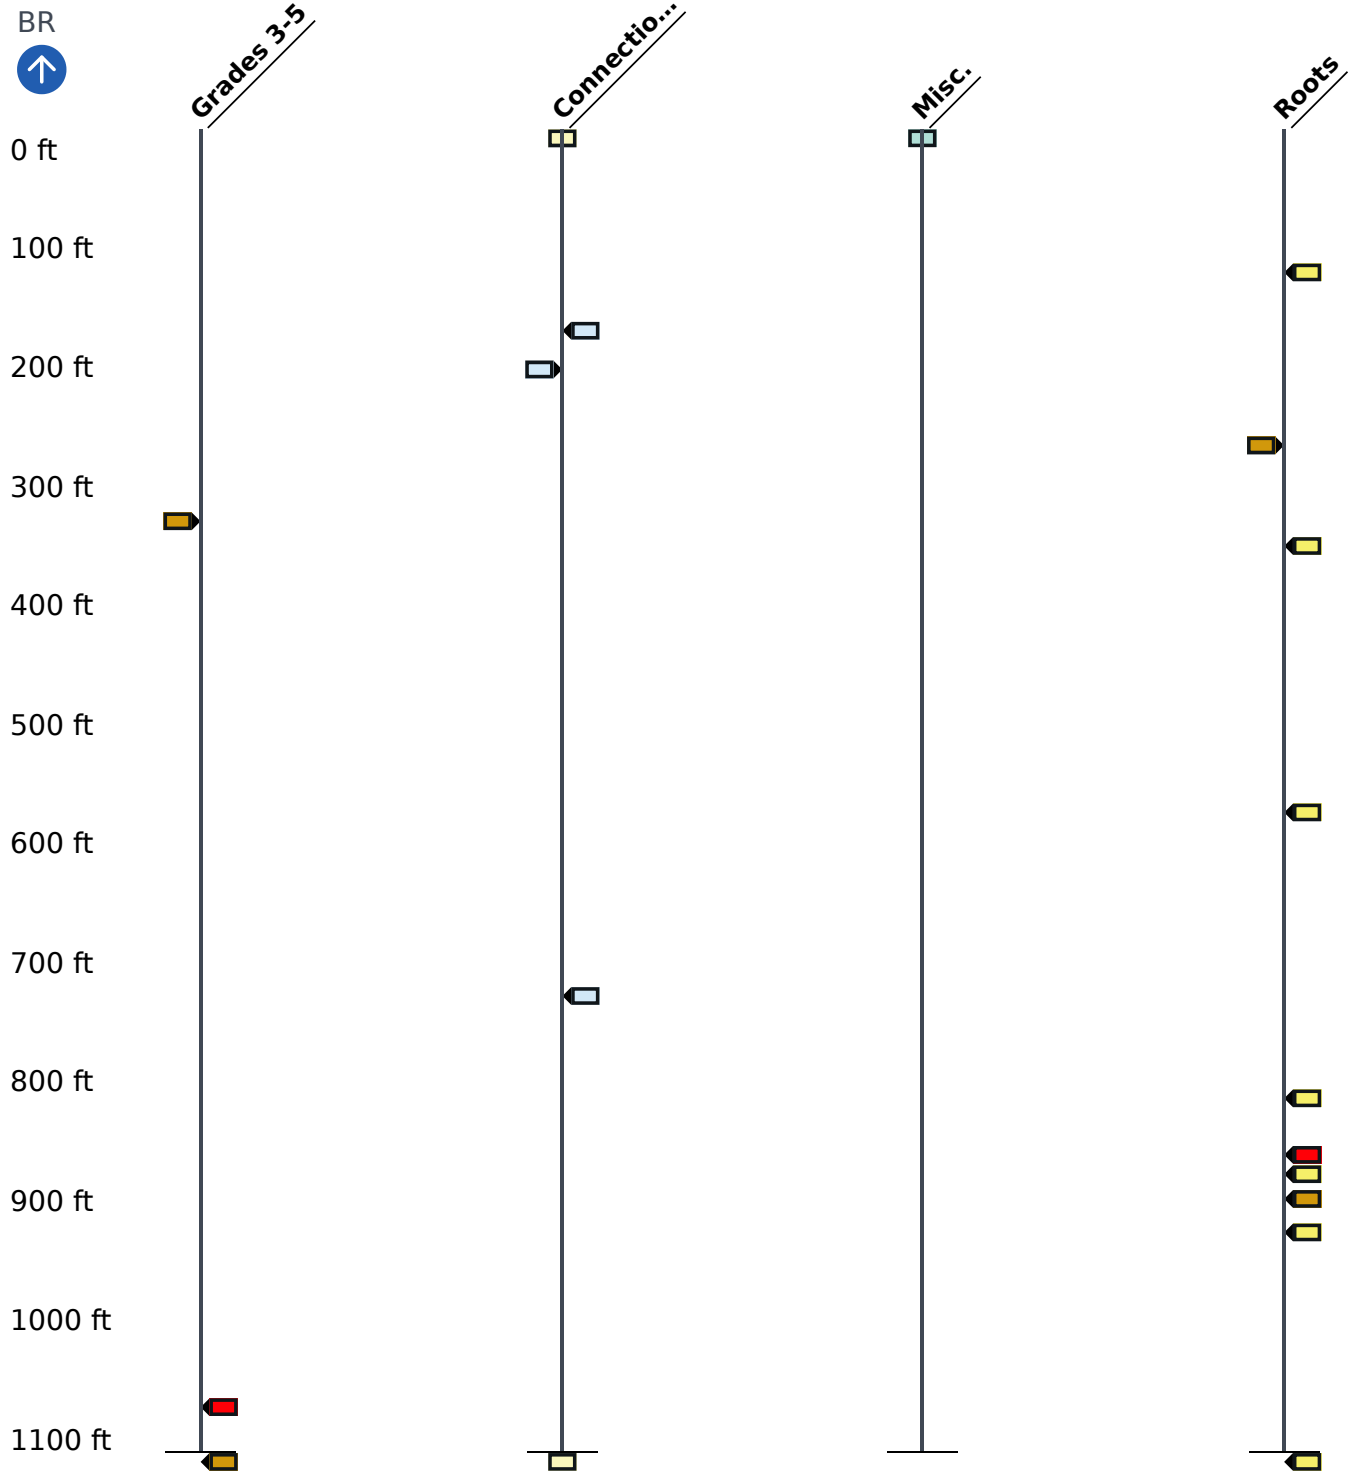
# SMART DIAGRAM

DATE: 10/3/2024  
PIPE SEG REF. MH 4A - MH 4  
UP MH: MH 4A  
DOWN MH: MH 4
