Inspection Marion County, Ohio

US Manhole 5

DS Manhole 4A

Sensor 3D Lidar

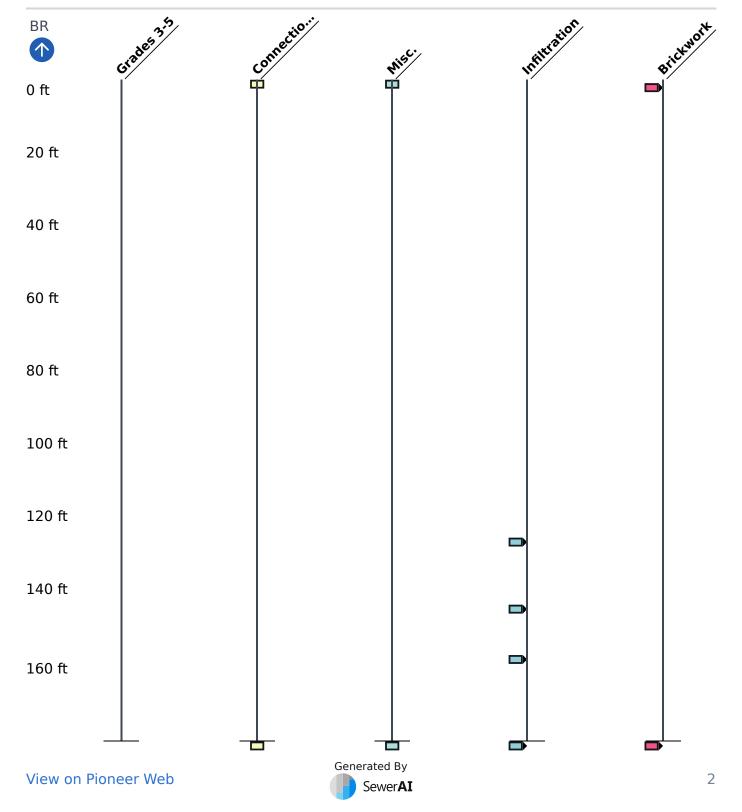
SMART DIAGRAM

PIPE SEG REF. MH 5 - MA 4A

UP MH: MH 5 DOWN MH: MH 4A

Dist	Time	Description	Code	Clock	Dim. 1	Dim. 2	%	Remarks	Cont.	Grade
0	0:05	Manhole	A l M	-	-	-	-	MH 4A	-	-
0	0:05	Miscellaneous Water Le vel	MLW	-	-	-	5	-	-	-
0	0:05	Miscellaneous General Observatio	MOG	-	-	-	-	10.1 FT OFFSE T	-	-
1	0:23	Missing Mortar Small	MBM		-	-	-	-	S01	2
1	0:31	Miscellaneous General Observatio	MOG	-	-	-	-	DAE LESS THA N 5%	-	-
50.9	1:03	Infiltration Weeper Barr el	IWB		-	-	-	-	-	2
58.4	1:07	Infiltration Stain Barrel	ISB		-	-	-	-	-	1
64	1:10	Infiltration Weeper Barr el	IWB		-	-	-	-	-	2
73.6	1:15	Infiltration Weeper Barr el	IWB		-	-	-	-	-	2
179	1:59	Missing Mortar Small	MBM		-	-	-	-	F01	2
179.6	1:59	Manhole	AHM	-	-	-	-	MH 5	-	-
