EXHIBIT 2 - VILLAGE OF FAIRPORT HARBOR
LCDU QUESTIONNAIRE RESULTS

LCDU - FAIRPORT HARBOR - I/I INVESTIGATION

LCDU - FAIRPORT HARBOR - SEWER I/I INVESTIGATION

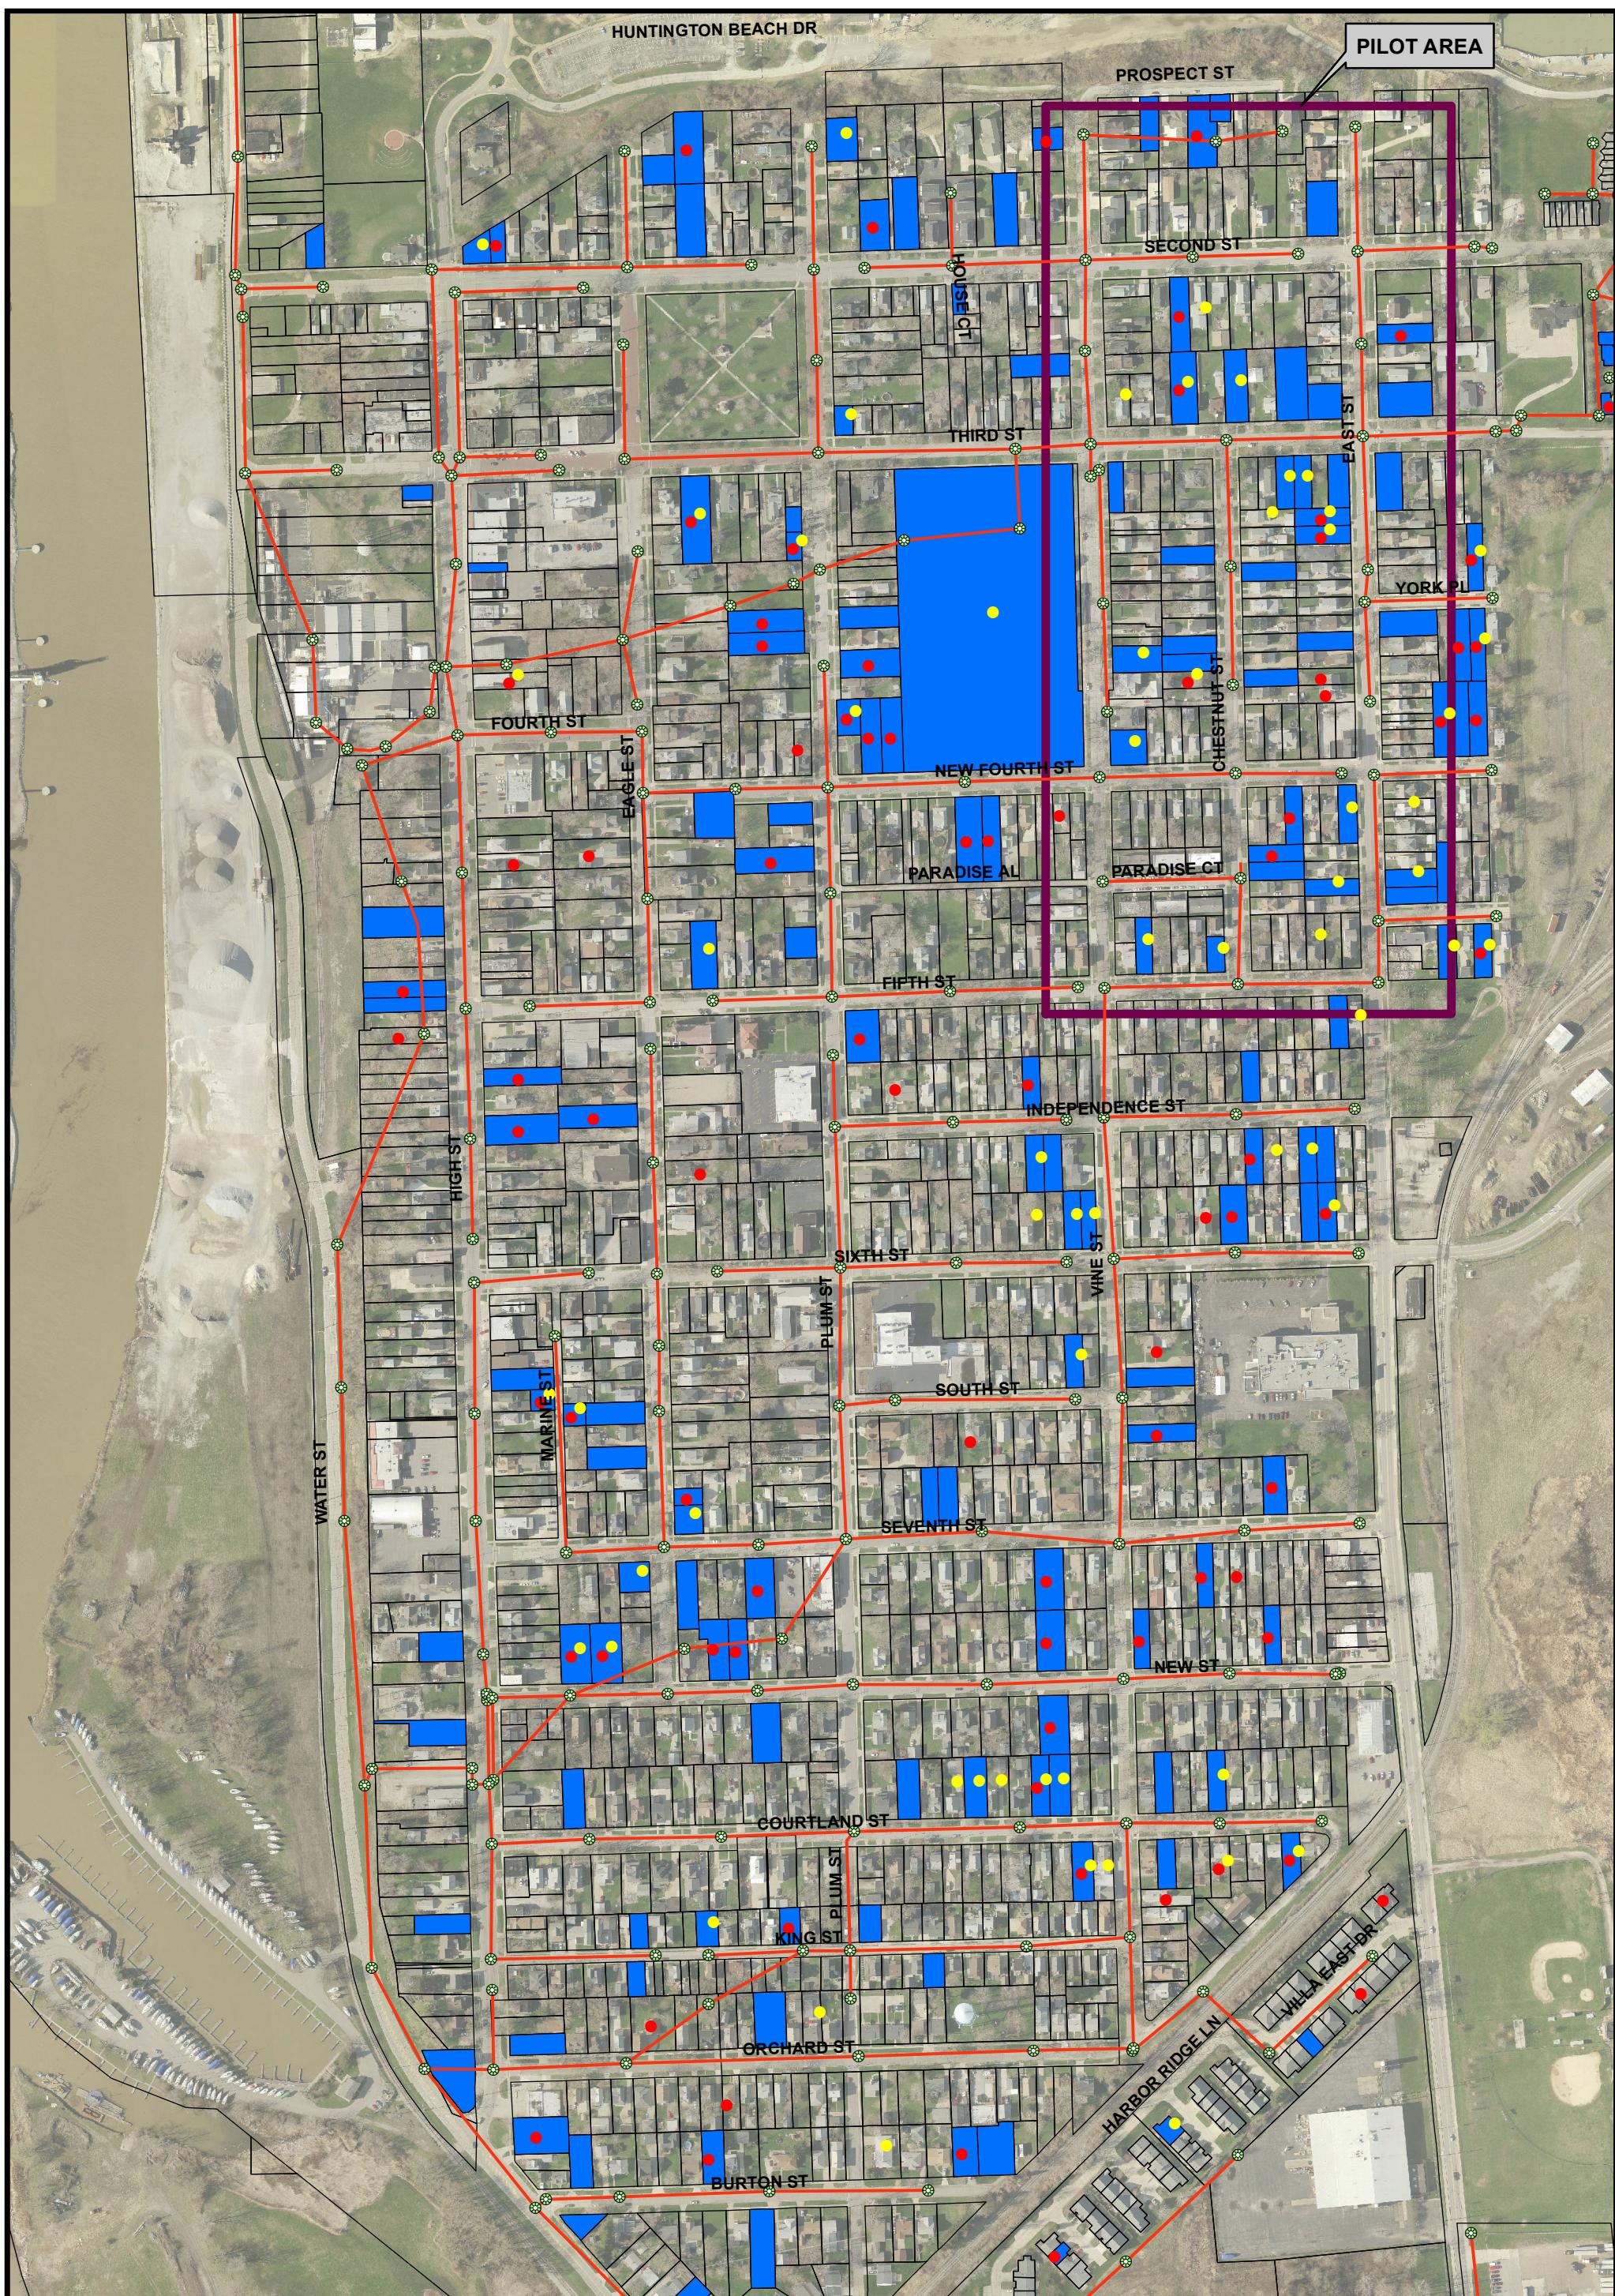
YARD FLOODING

STREET FLOODING

BASEMENT FLOODING

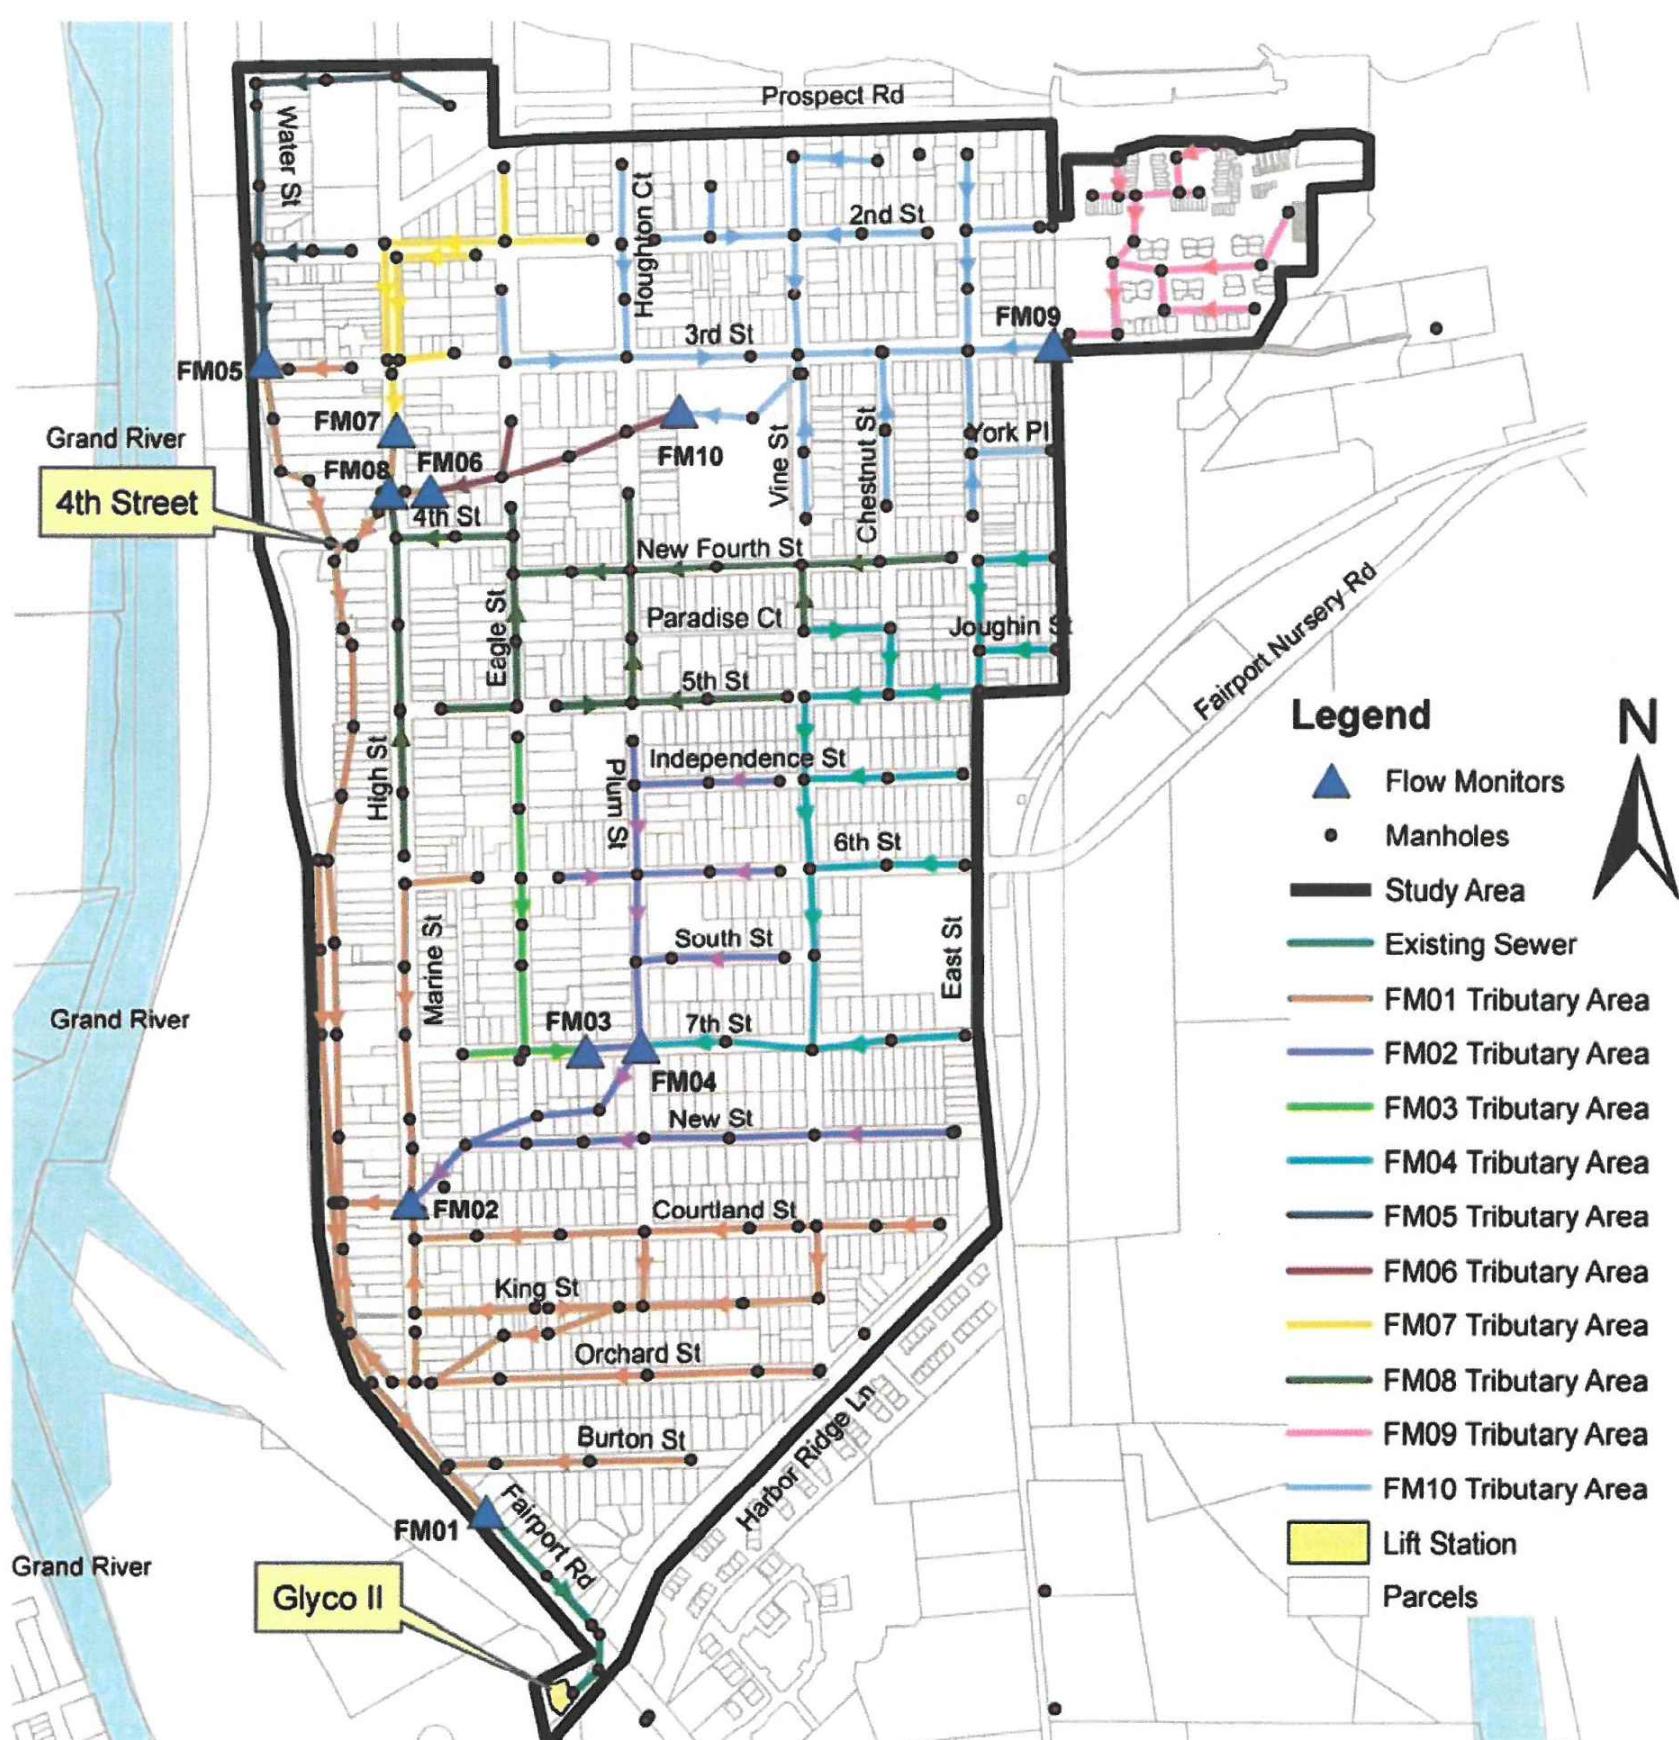
Rank	Individual Flow Monitor	Calculated Individual Peak I/I (gpd)	Individual Basin Ave. DWF (gpd)	Peaking Factor
1	FM08	1,693,286	45,210	37.5
2	FM10	2,022,603	78,078	25.9
3	FM06	1,053,230	67,103	15.7
4	FM07	605,190	41,094	14.7
5	FM04	880,238	62,457	14.1
6	FM02	612,929	58,169	10.5
7	FM03	325,611	32,134	10.1
8	FM09	121,111	12,540	9.7
9	FM01	1,425,794	308,503	4.6
10	FM05	178,833	68,731	2.6

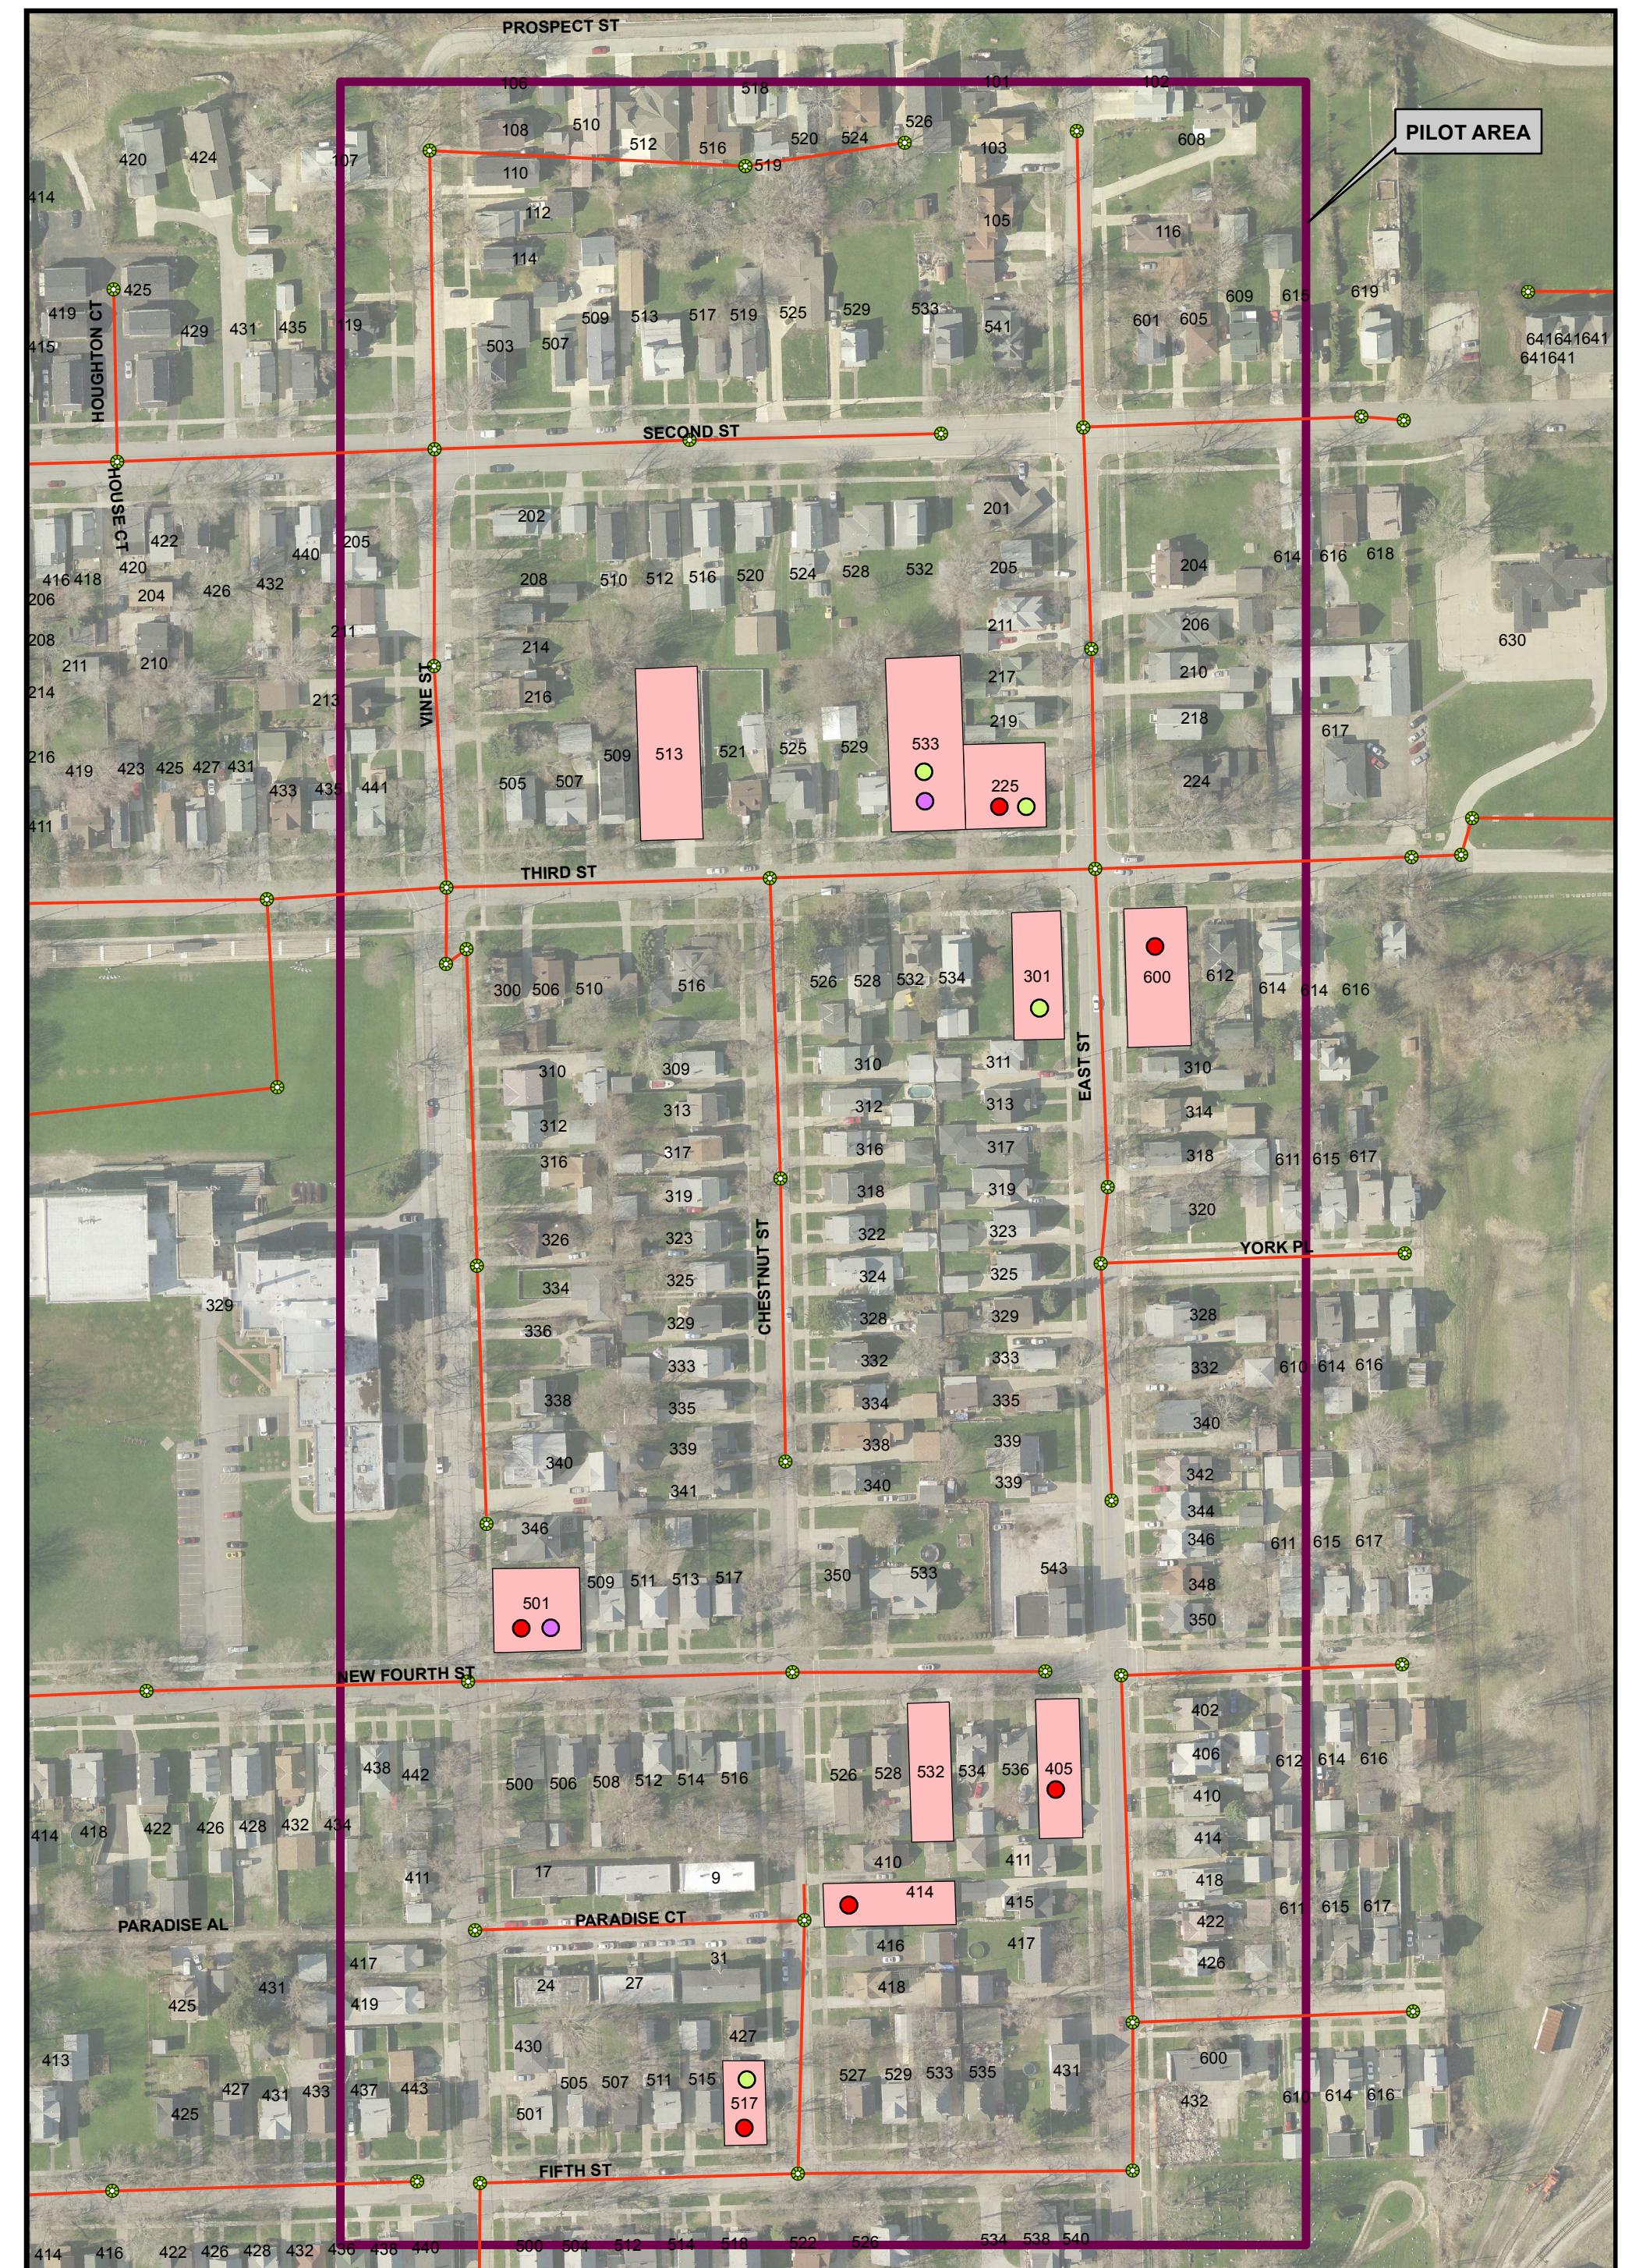
EXHIBIT 5 - VILLAGE OF FAIRPORT HARBOR
SANITARY SEWER SYSTEM
RECOMMENDED REPAIRS

- SANITARY MANHOLE
- SANITARY SEWER REVIEWED
- SANITARY SEWER OUTSIDE PILOT AREA
- SANITARY SEWER LINING RECOMMENDED

- PILOT AREA
- SANITARY SEWER POINT REPAIR

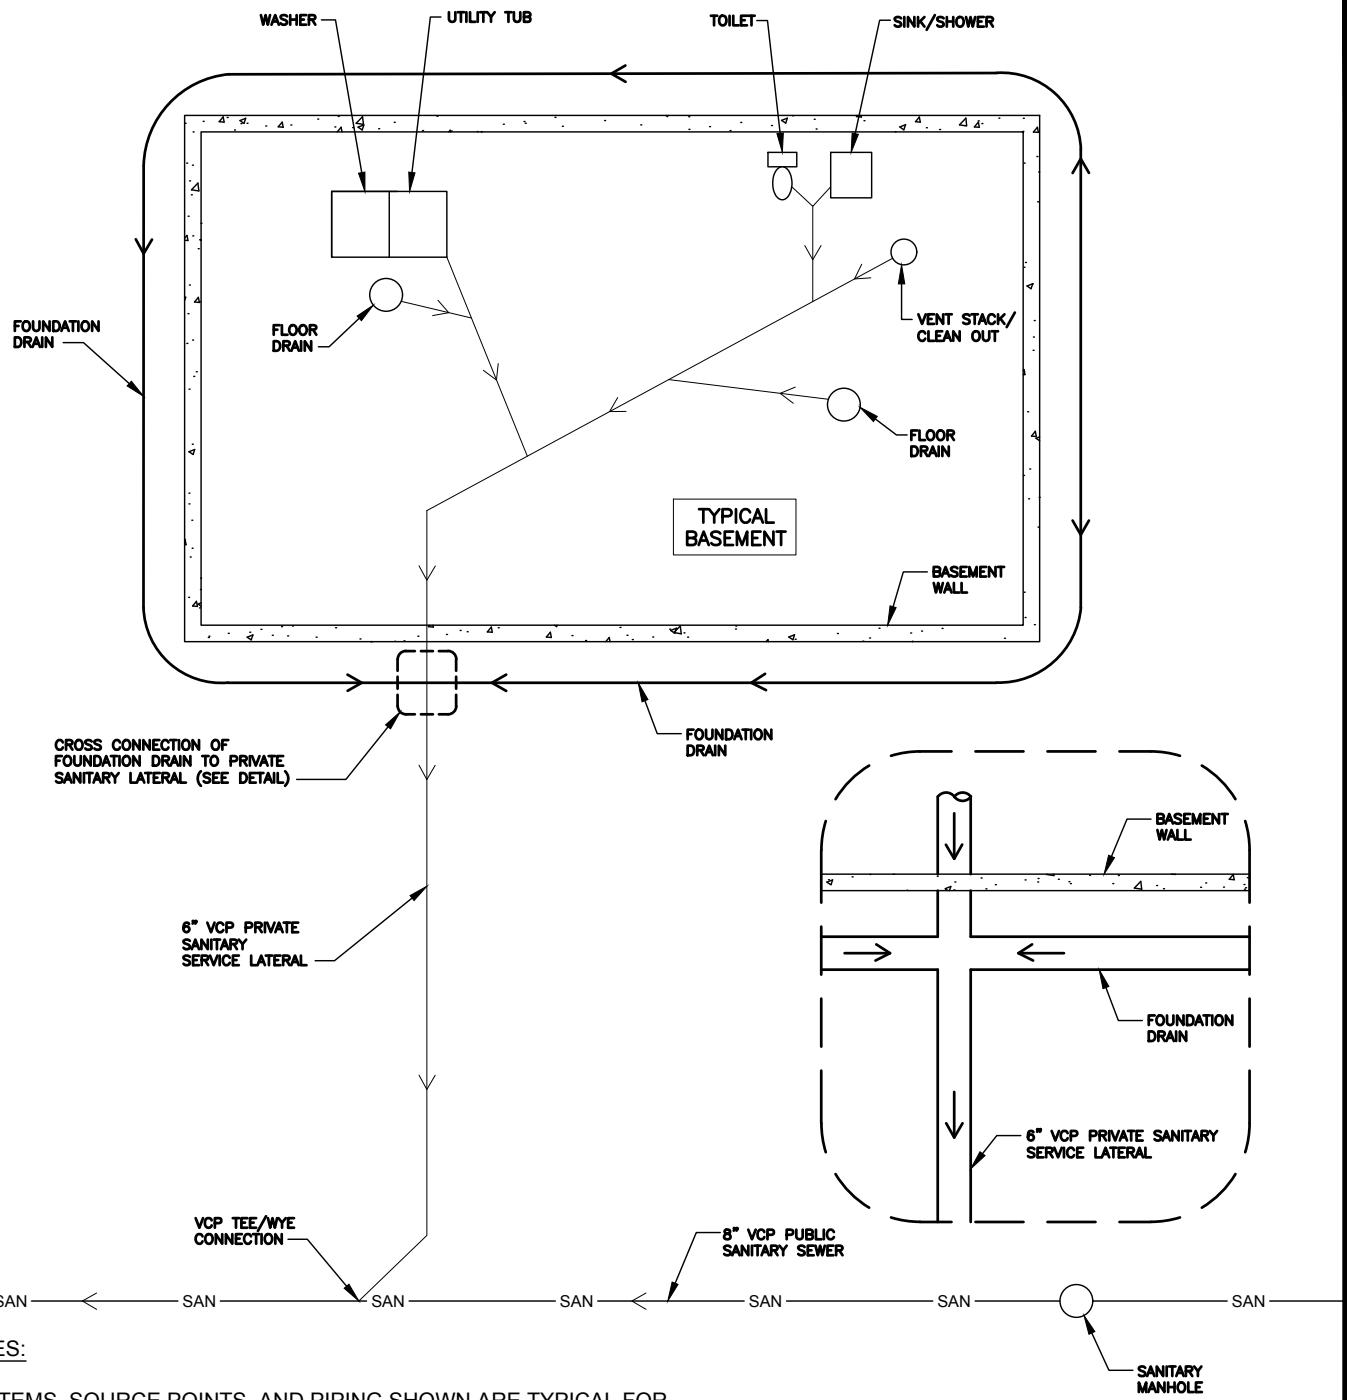
SKETCH 1
TYP. BASEMENT PLUMBING

1. ITEMS, SOURCE POINTS, AND PIPING SHOWN ARE TYPICAL FOR BASEMENTS OBSERVED. ACTUAL CONDITIONS AND CONFIGURATIONS WILL VARY FROM HOUSE TO HOUSE.
2. THE ONLY CLEAN-OUTS OBSERVED WERE LOCATED ON VENT STACKS. NO OUTSIDE CLEAN-OUTS WERE DETECTED DURING PRIVATE SANITARY LATERAL INSPECTION.
3. TYPICAL DOWNSPOUTS DISCHARGED TO SPLASH BLOCKS OR PIPED TO SIDEWALK/TREE LAWN. DURING TESTING TWO HOUSES WERE IDENTIFIED AS HAVING DOWNSPOUTS PREVIOUSLY TIED INTO THE PRIVATE SANITARY LATERAL.
