**Sanitary & Storm Sewers
Inflow & Infiltration Investigation
Lake County Department of Utilities**

Village of Fairport Harbor

June 2017

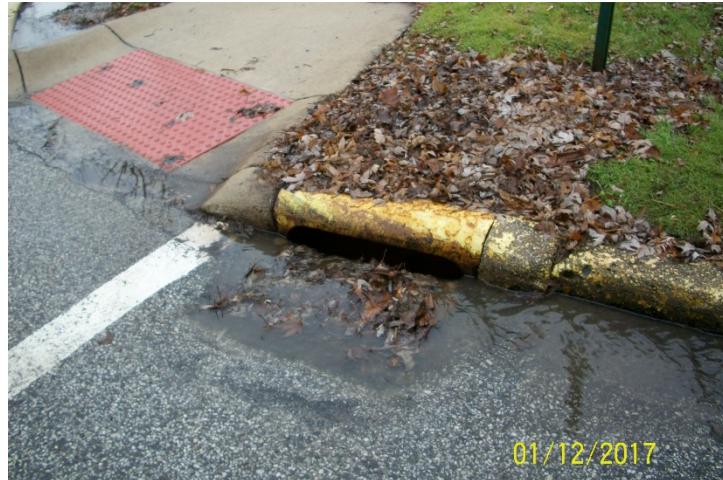
Fifth St. at East St.

During the rain events B&N opened both sanitary and storm manholes to observe the flows in the pipes during wet weather. The storm manholes showed normal flowing conditions with gradual flow and no signs of surcharging. After opening several sanitary manholes it was evident that storm water was finding its way into the sanitary system causing a significant increase in flow. The picture below shows large amounts of clear water moving through the sanitary system. These areas were observed to have high I/I related flows in the public sanitary sewers:

- Third St. and East St. – I/I from the south pipe
- Third St. and Vine St. – I/I from north and east pipe
- Fifth St. and Chestnut St. – I/I from north pipe

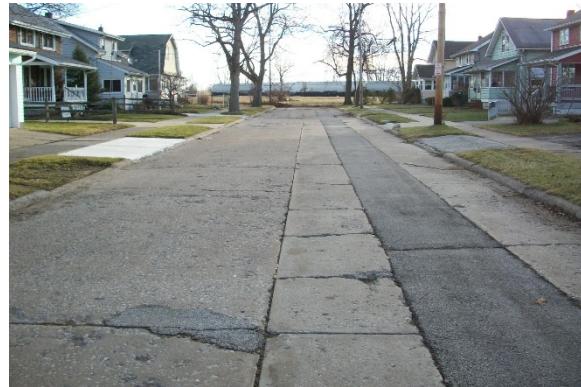
Paradise Ct.
No Curb For Stormwater Conveyance

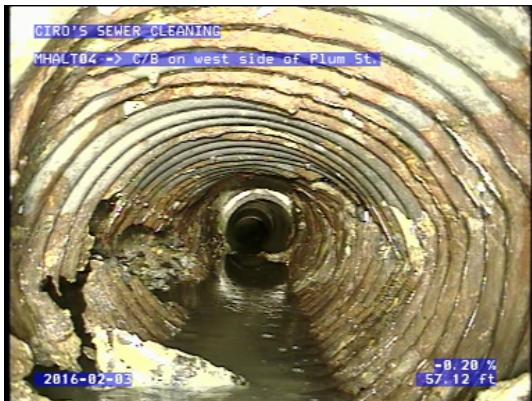
STS - Plum St. - CMP Deformed; Hole in Pipe

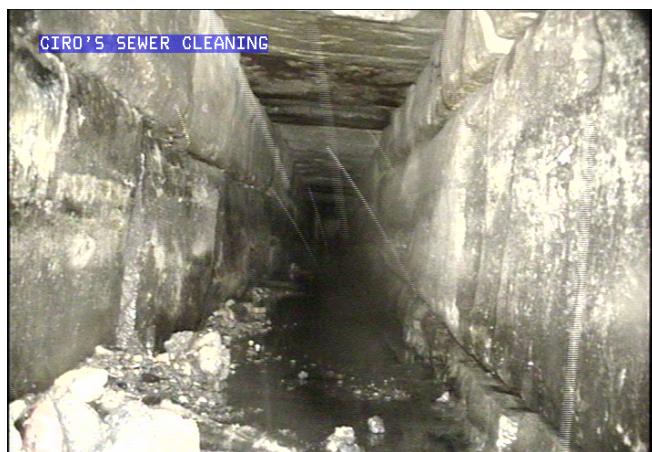
STS - High St. – Box Culvert After Cleaning
