PACP Report with Pipe Run and Incident Snapshots

Surveyed by: ANDREW		Certificate number: T-507-4975		Owner: CITY OF MARION		Customer:		Drainage area:		P/O number:		Sheet number:							
Pipe segment ref.: MH10_MH9				Start date/time: 20240626 08:39		Street: 876 SILVER ST.				City: MARION, OH									
Location details:				Upstream MH No: MH10				Rim to invert:		Grade to invert:		Rim to grade:							
Pipe use: CB		Direction: U		Flow control:		Downstream MH No: MH9				Rim to invert:		Grade to invert:		Rim to grade:					
Height: 66 in.		Width:		Shape: C		Material: BR		Lining method:		Pipe joint length:		Total length: 785.200 ft.		Length surveyed: 785.200 ft.		Purpose: B		Sewer category:	
Media label:				Pre-cleaning: N		Date cleaned:		Weather: 1		Location code: C		Pressure value:							
Project name: ROCK SWALE 72 IN INSPECTION				Additional info:

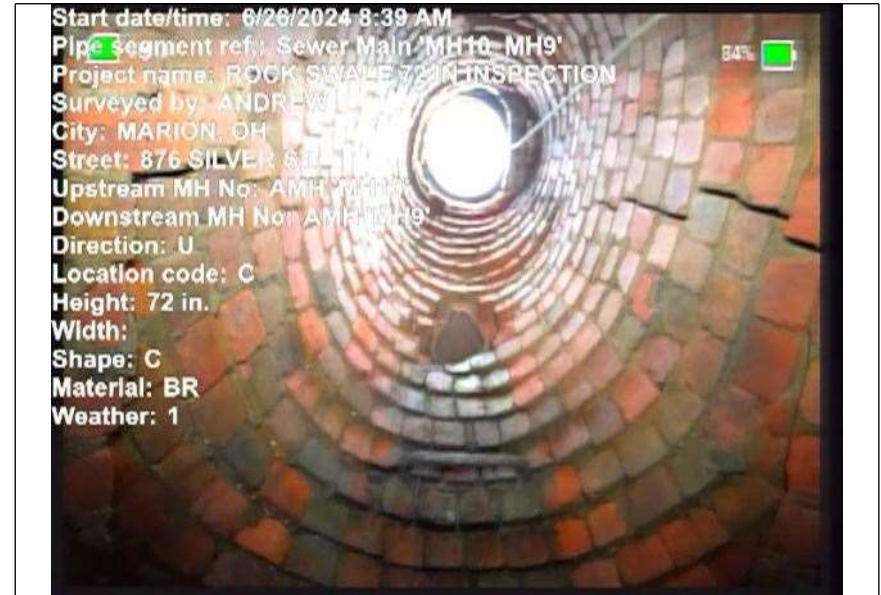
At: 0 ft. AMH - Manhole
Joint: No MH9

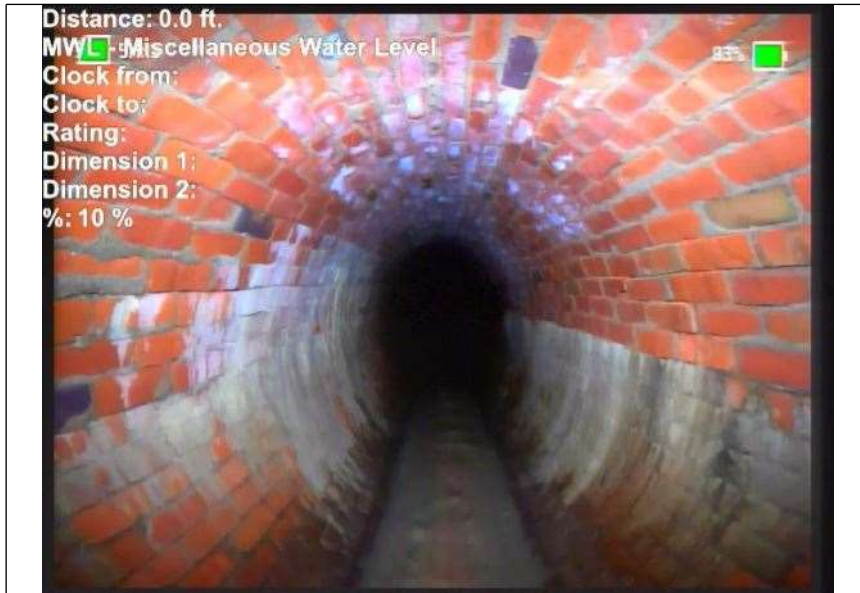
Distance: 0.0 ft.
MWL - Miscellaneous Water Level
Clock from:
Clock to:
Rating:
Dimension 1:
Dimension 2:
%: 10 %

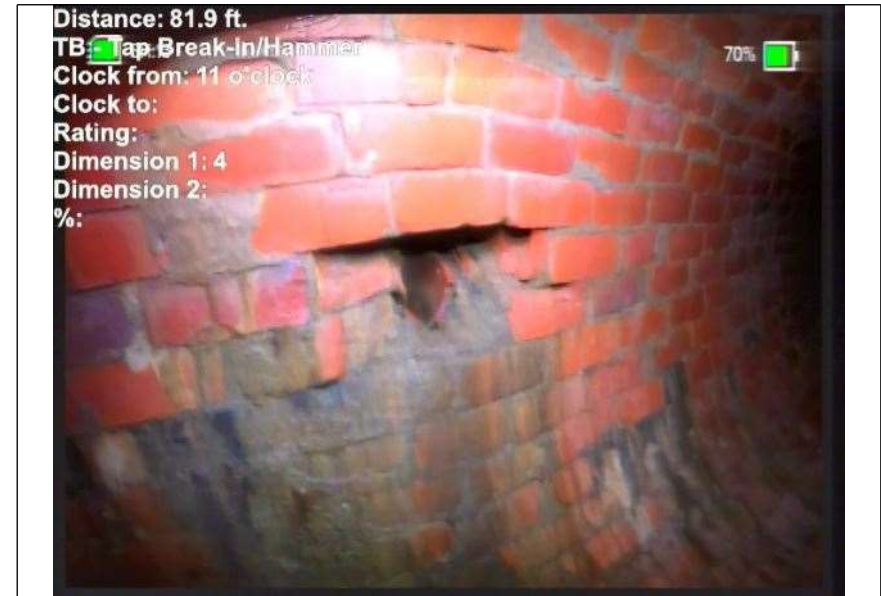
At: 81. 9000015258 TB - Tap Break-in/Hammer
789 ft. 11/.
Joint: No

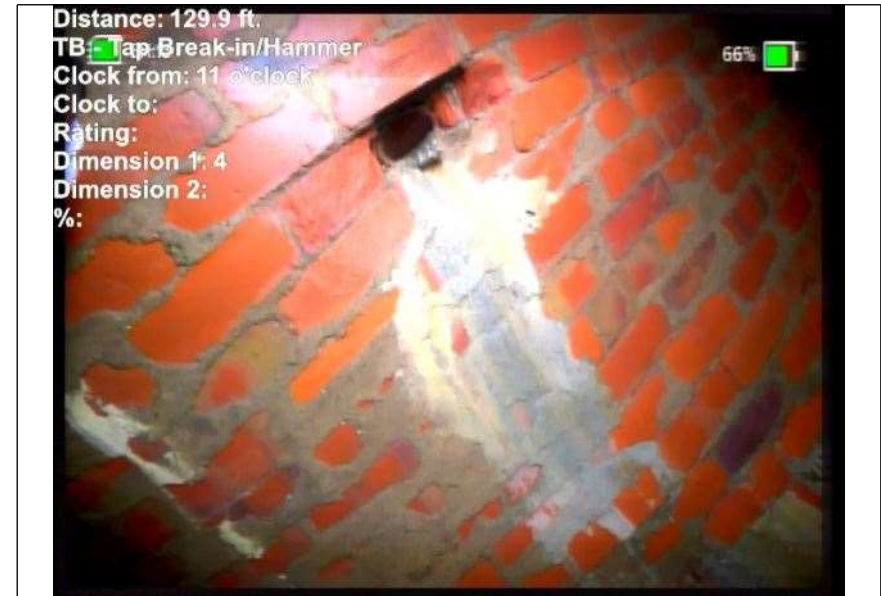
At: 129. TB - Tap Break-in/Hammer
8999938964
84 ft. 11/.

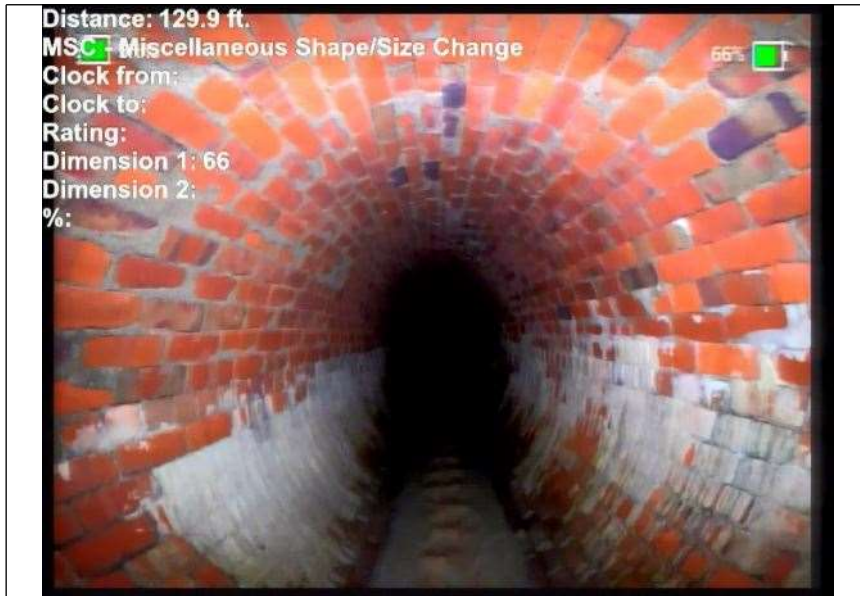
At: 129. MSC - Miscellaneous Shape/Size Change
8999938964
84 ft.

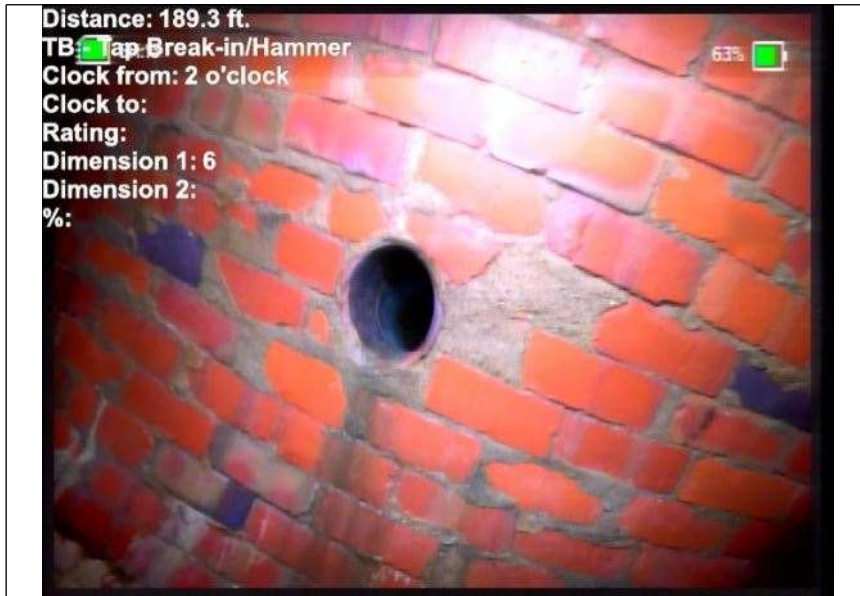
At: 189. TB - Tap Break-in/Hammer
3000030517
58 ft. 2/.

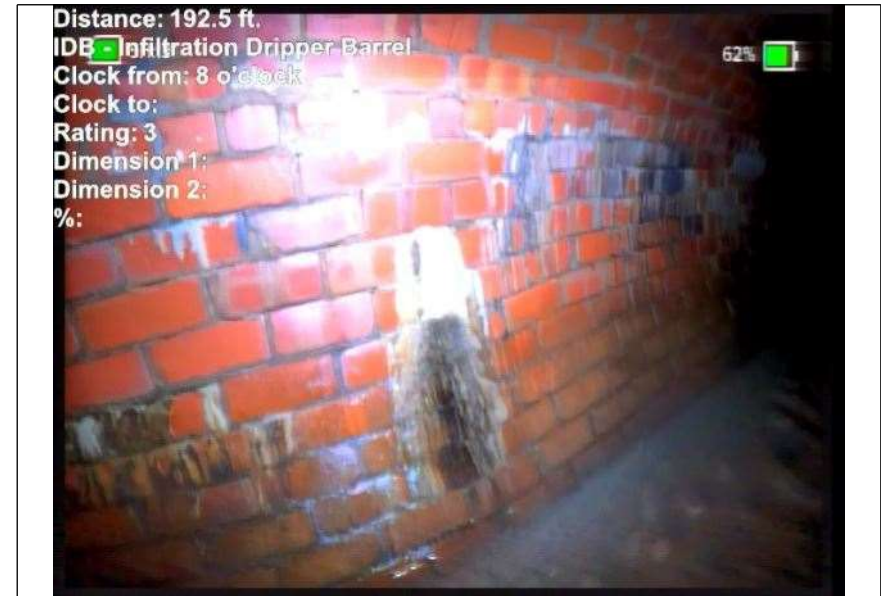
At: 192.5 ft. 8/. IDB - Infiltration Dripper Barrel
Joint: No

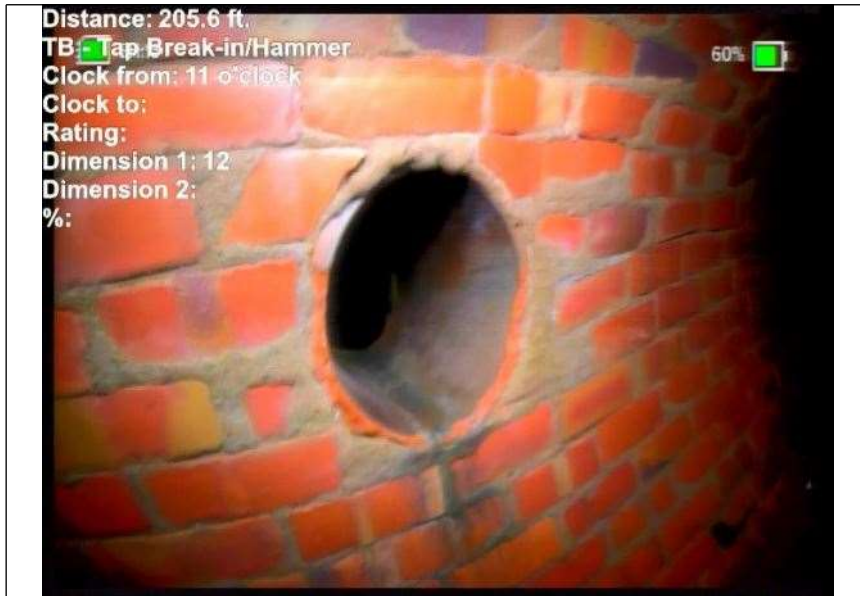
At: 205. TB - Tap Break-in/Hammer
6000061035
16 ft. 11/.

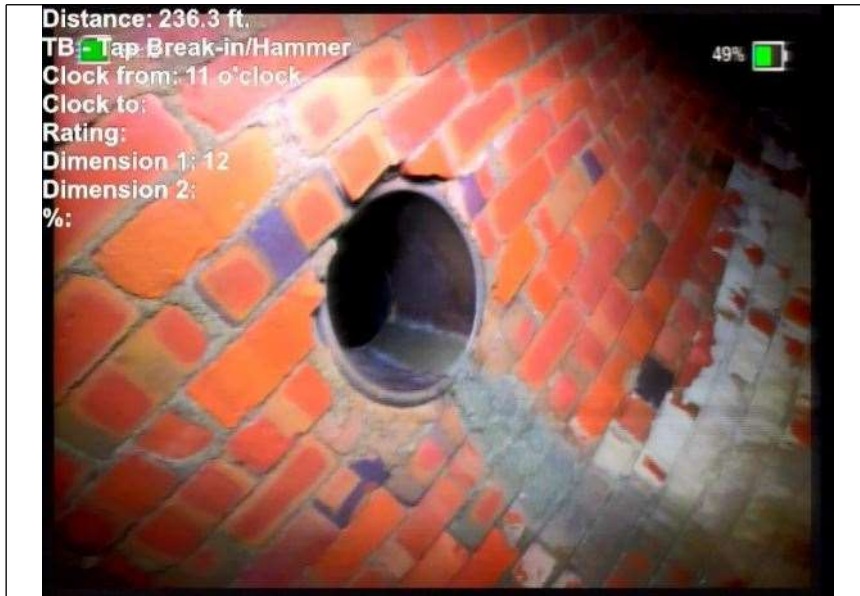
At: 236. TB - Tap Break-in/Hammer
3000030517
58 ft. 11/.

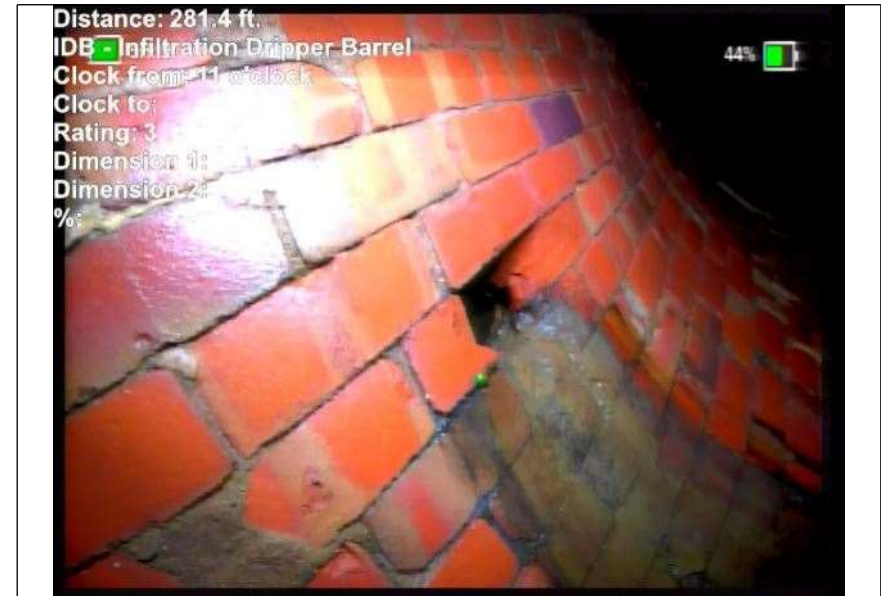
At: 281. IDB - Infiltration Dripper Barrel
3999938964
84 ft. 11/.

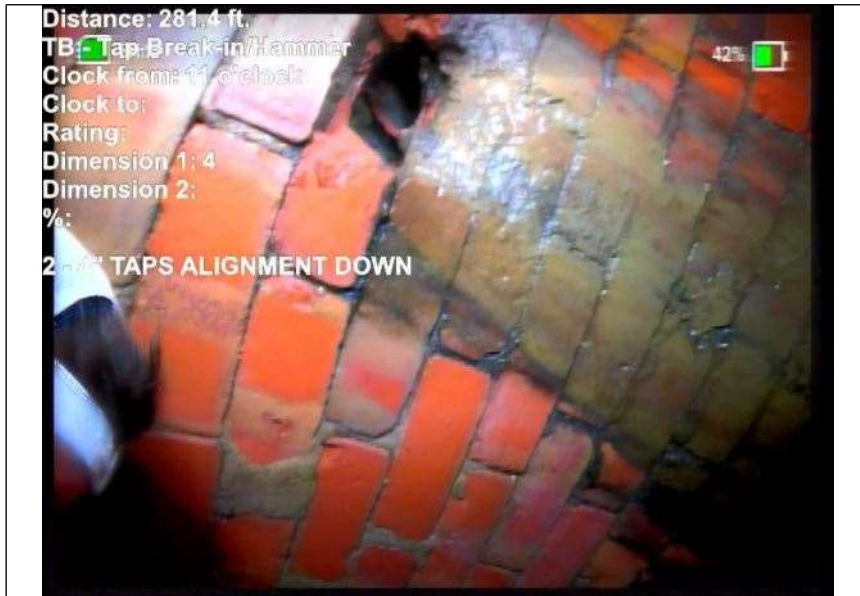
At: 281. TB - Tap Break-in/Hammer
3999938964
84 ft. 11/.

Joint: No 2 - 4" TAPS ALIGNMENT DOWN

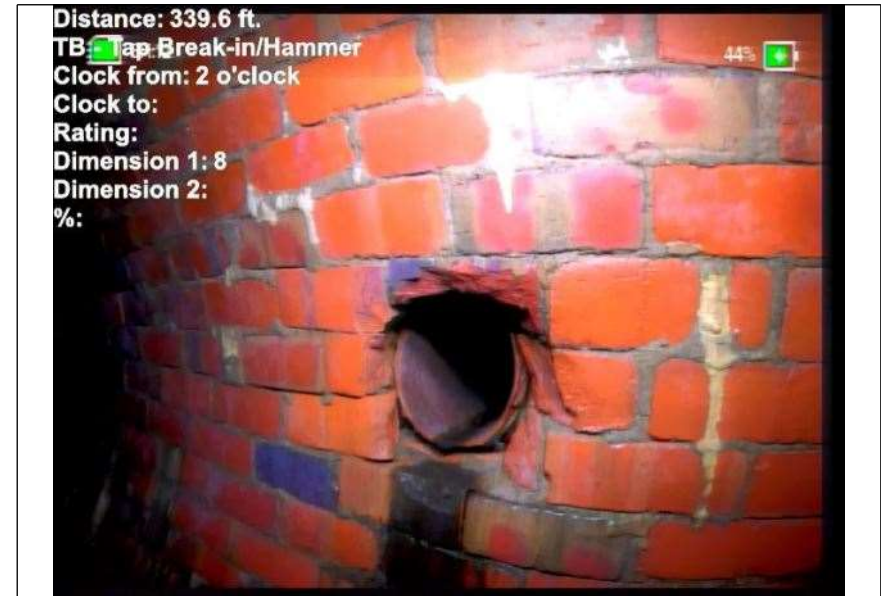
At: 339. TB - Tap Break-in/Hammer
6000061035
16 ft. 2/.

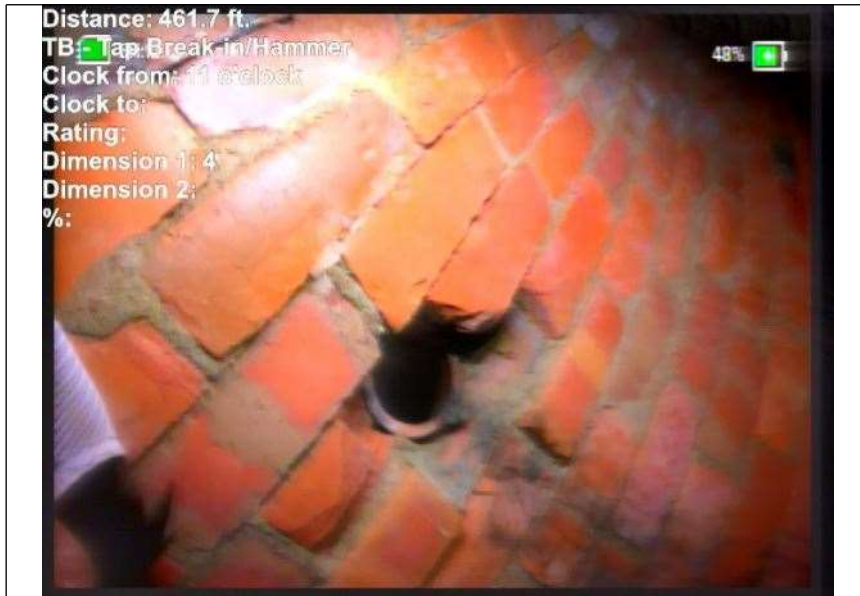
At: 461. TB - Tap Break-in/Hammer
7000122070
31 ft. 11/.

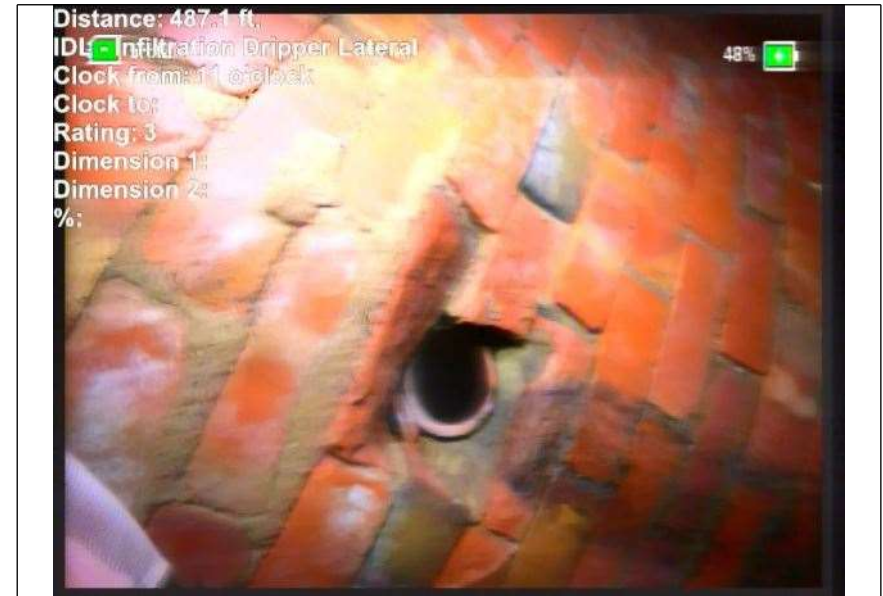
At: 487. IDL - Infiltration Dripper Lateral
1000061035
16 ft. 11/.

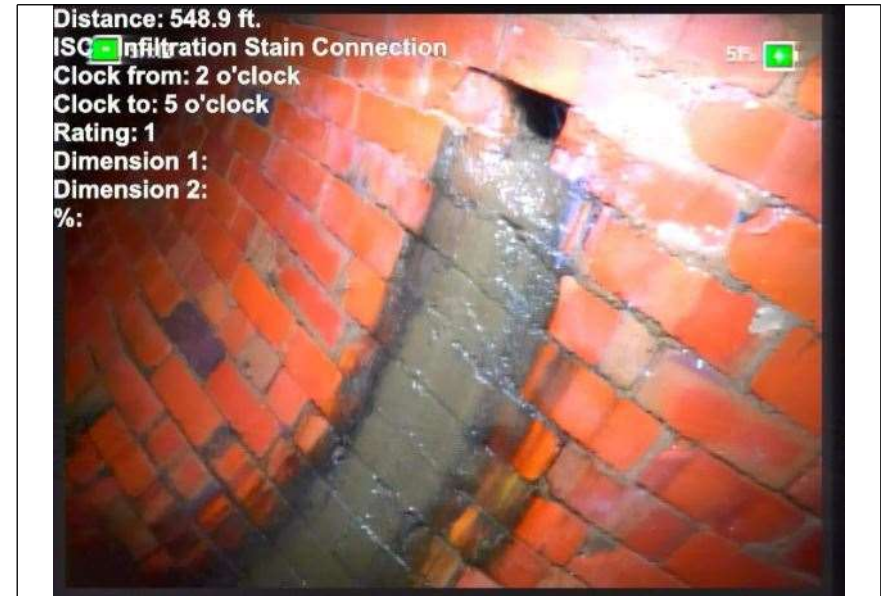
At: 548. ISC - Infiltration Stain Connection
9000244140
63 ft. 2/5

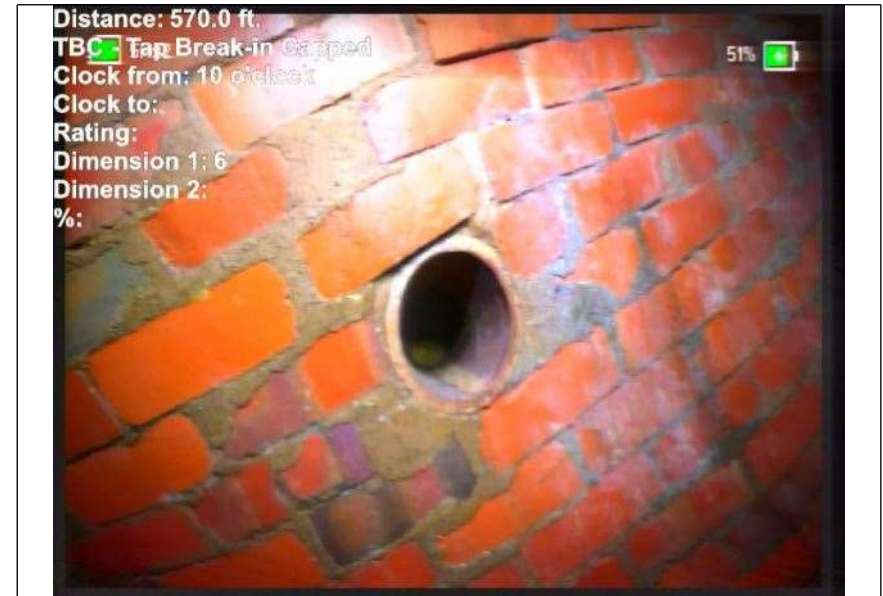
At: 570 ft. 10/. TBC - Tap Break-in Capped
Joint: No

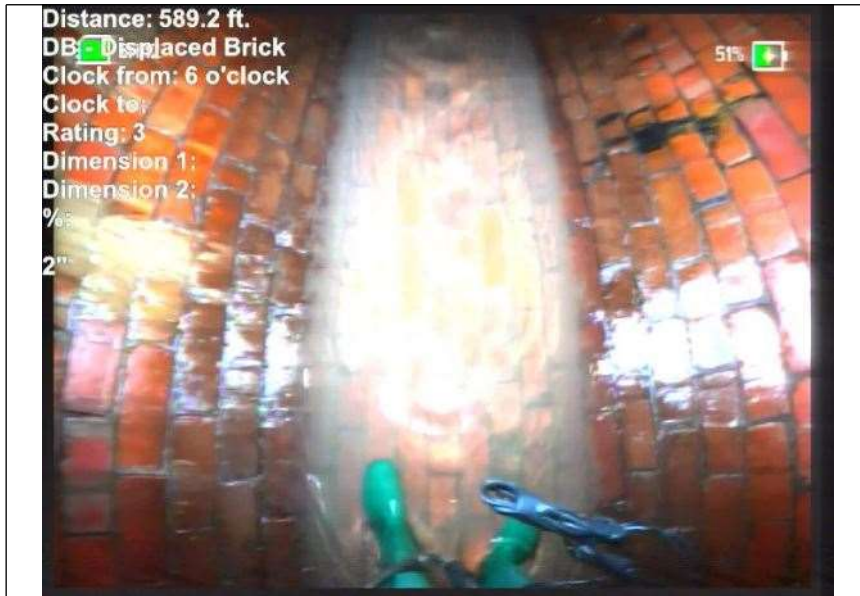
At: 589. DB - Displaced Brick
2000122070
31 ft. 6/.

Joint: No 2"

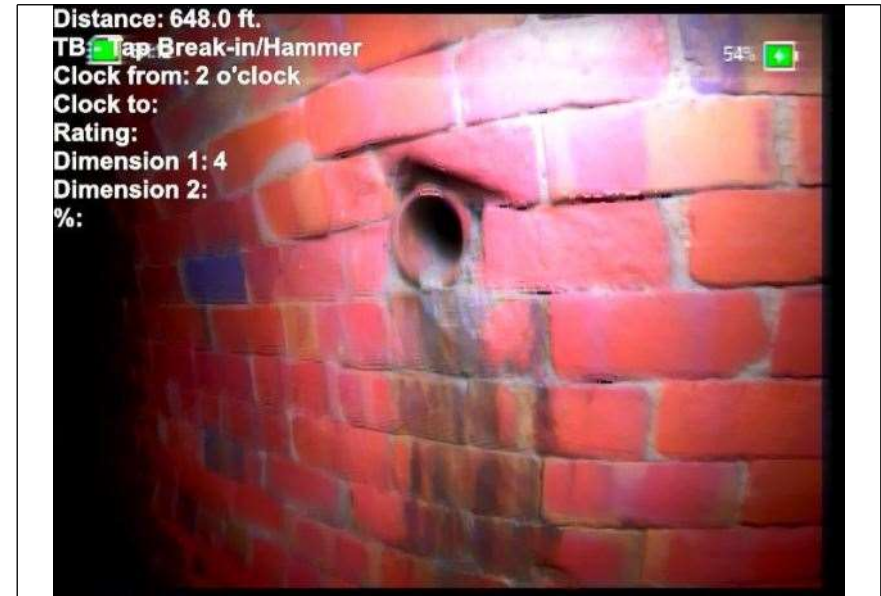
At: 648 ft. 2/. TB - Tap Break-in/Hammer
Joint: No

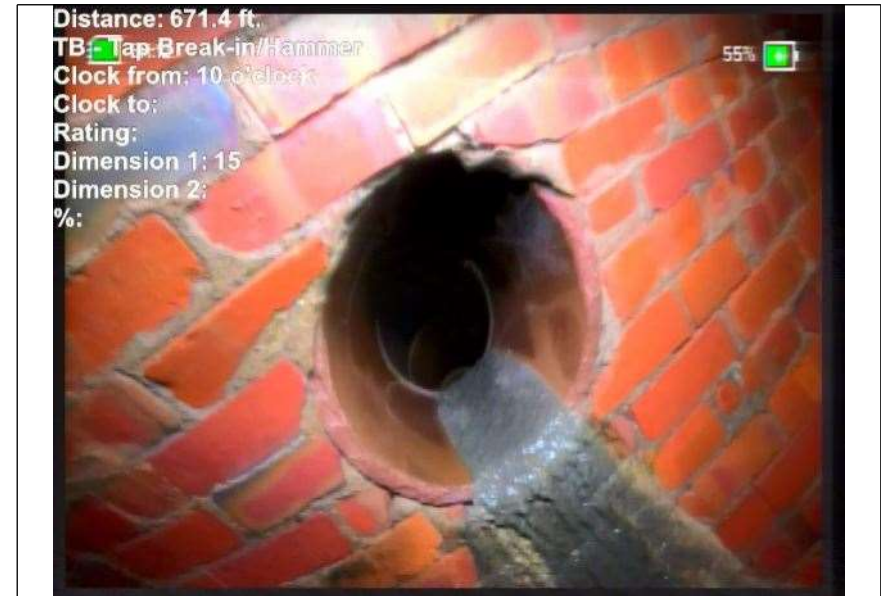
At: 654. TBD - Tap Break-in/Hammer Defective
9000244140
63 ft. 10/.

Joint: No FRACTURE 6 OCLOCK ACTIVE

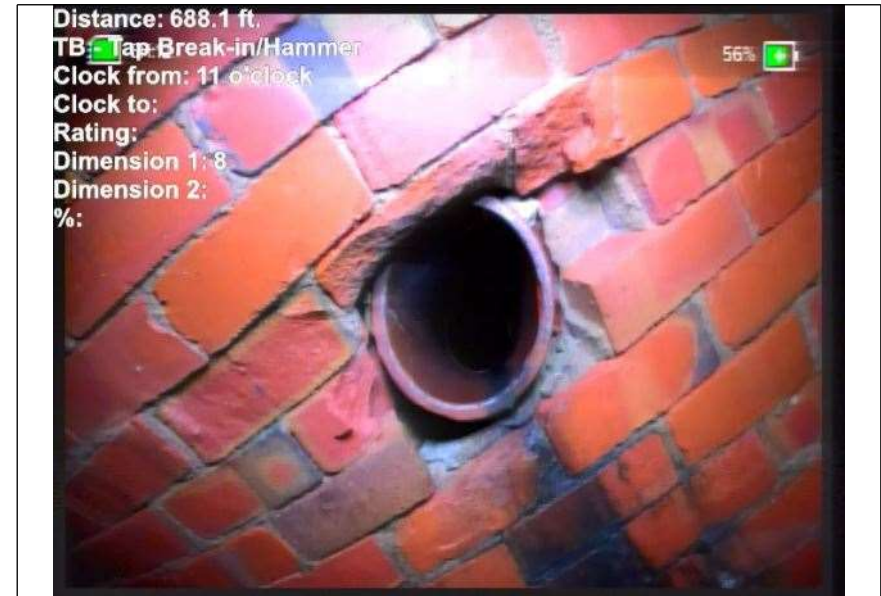
At: 671. MGO - Miscellaneous General Observation
4000244140
63 ft.

Joint: No 7-11 <5% SCALE

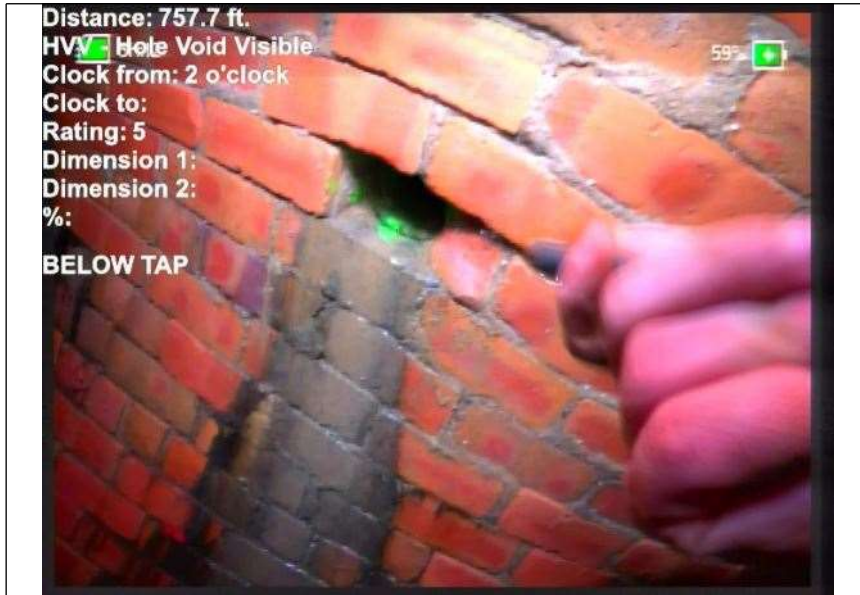
At: 757. TBD - Tap Break-in/Hammer Defective
2999877929
69 ft. 2/.

Joint: No RECESSED 4"
